Little Diomed Health Clinic

Alaska Rural Primary Care Facility

Assessment and Inventory Report

April 11, 2002

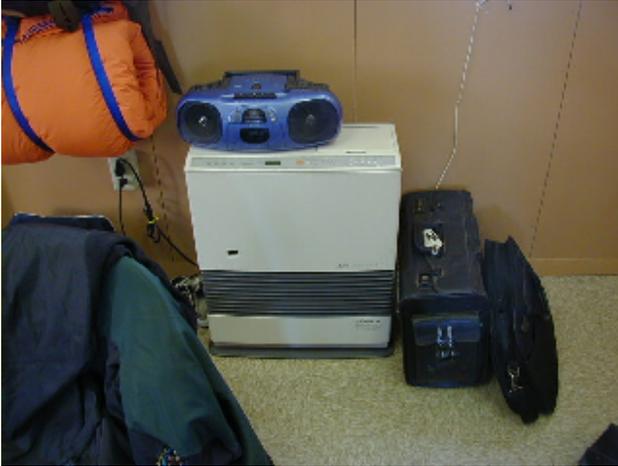
MGE01
Monitor Stove in Waiting Room

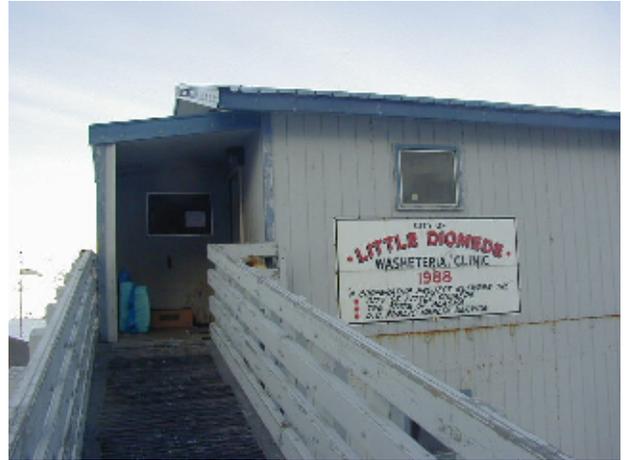
- e. Exterior Windows: Windows are PVC double pane and are in good condition.
- f. Exterior Decks, Stairs, and Ramps: The sole entrance to the clinic is via a ramp that is too steep and lacks handrails.

MGE02
Front Entrance

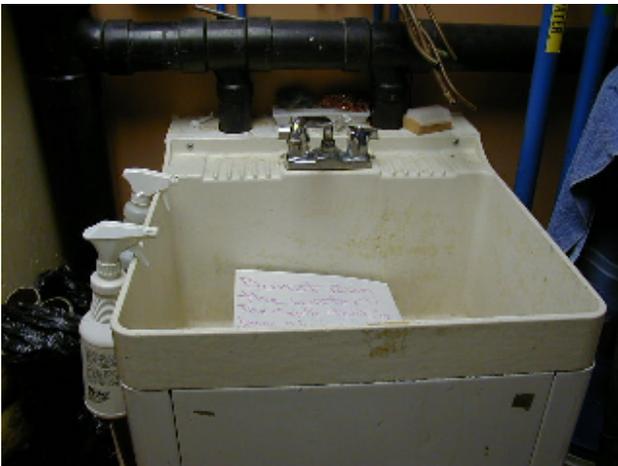
MGE03
Janitor's Sink, No Vacuum Breaker

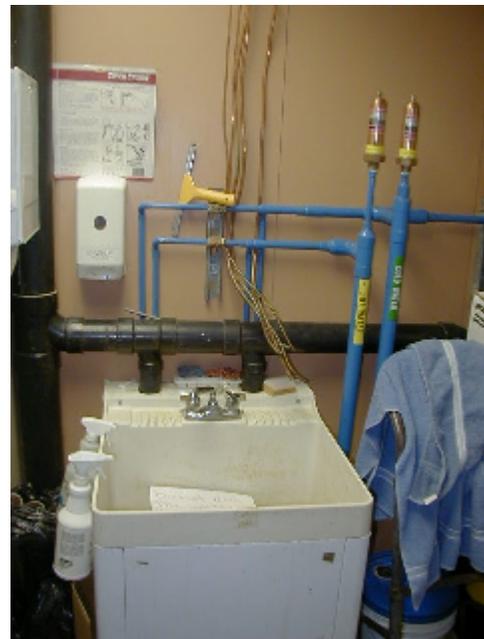
MGE04
Janitor's Sink, Glycol Air Vent Lines

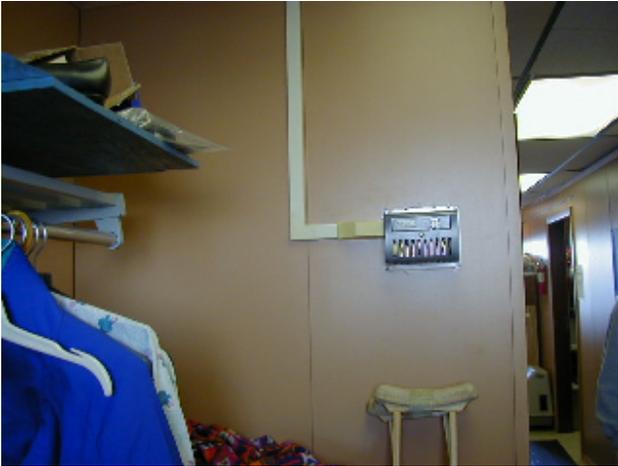
MGE05
Unit Heater Thermostat

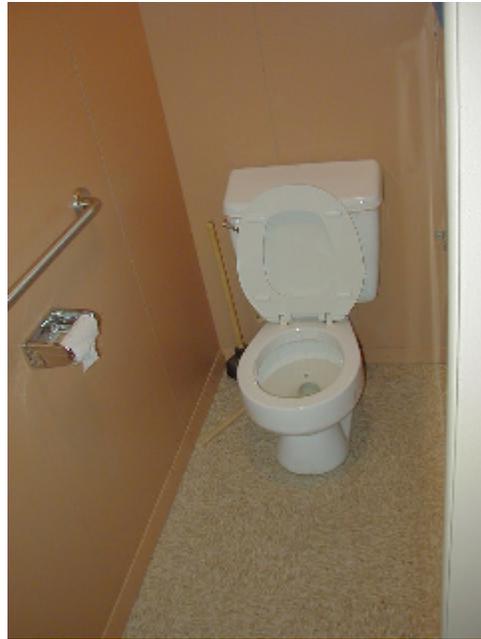
MGE06
Restroom Toilet, Non-ADA

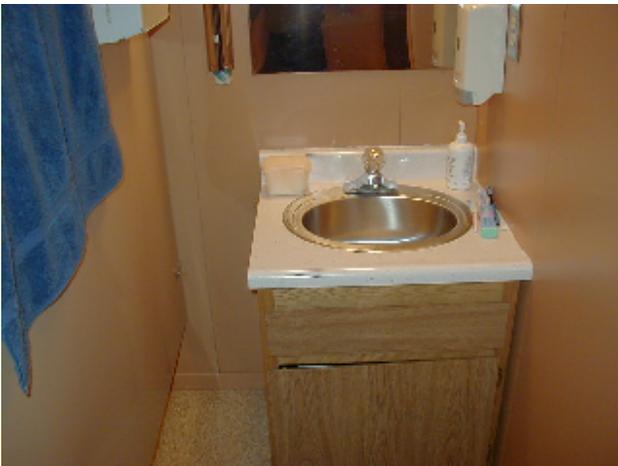
MGE07
Restroom Lav, Non-ADA

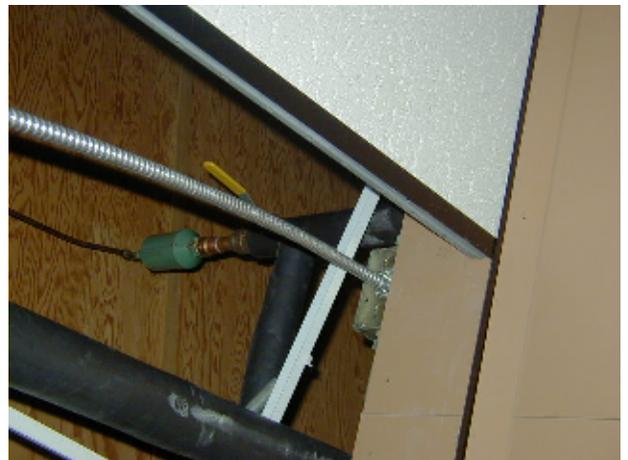
MGE08
Heating System Air Vent Above Ceiling

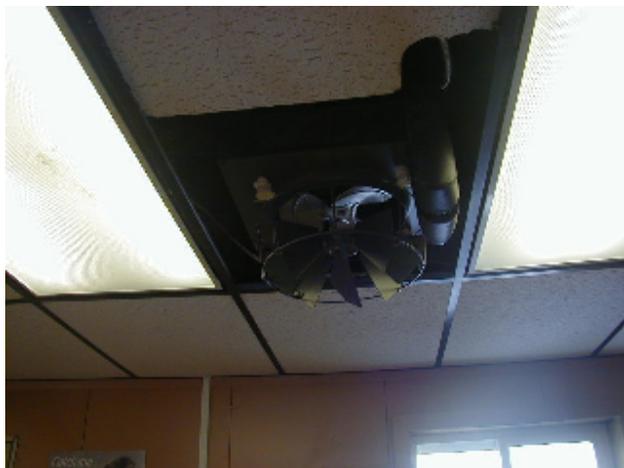
MGE09
Unit Heater in Waiting Room

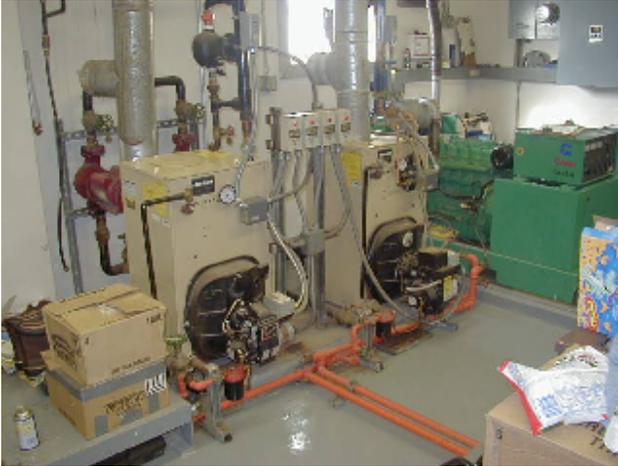
- c. Boilers (Water Treatment Plant): The boilers and waste heat recovery system provide the heat for the water treatment building, water storage tank, and the washeteria/clinic. Two residential grade cast iron sectional oil-fired boilers (Weil-Mclain with a Beckett AFG burner) are located in the water treatment plant. The heat for the clinic is piped over to the clinic via above ground piping. The clinic heat is then distributed throughout the clinic via hydronic baseboard units located in the perimeter rooms; and through a unit heater located in the waiting room. The baseboard in the facility is residential grade and is controlled by self-contained control valves on each baseboard unit. A wall mounted thermostat controls the unit heater located in the waiting room ceiling. The heating system uses glycol as the heating medium.

MGE17
Boilers in the Water Treatment Building

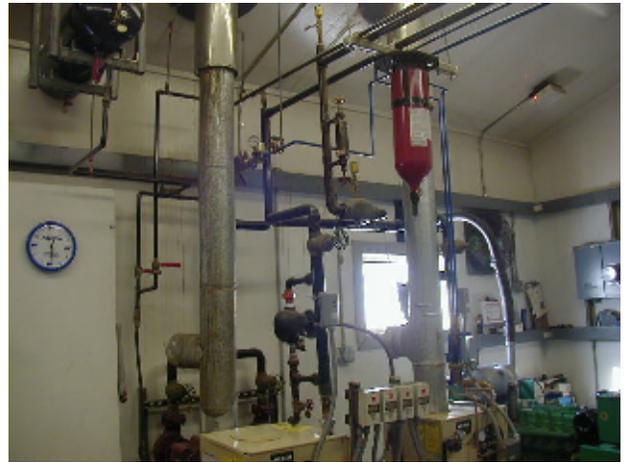
MGE18
Boiler Flues in the Water Treatment Building

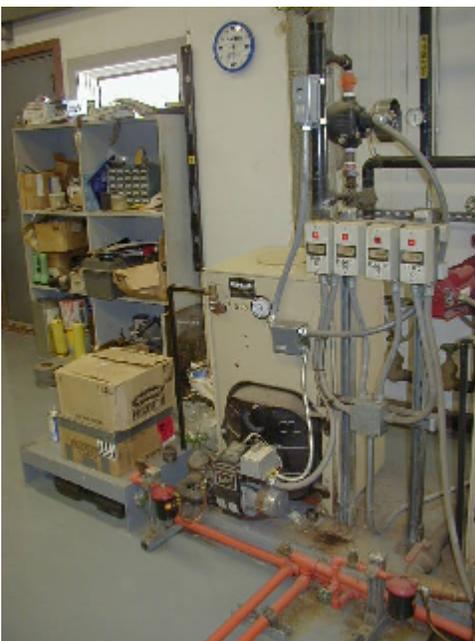
MGE19
Boiler and Pump Controls

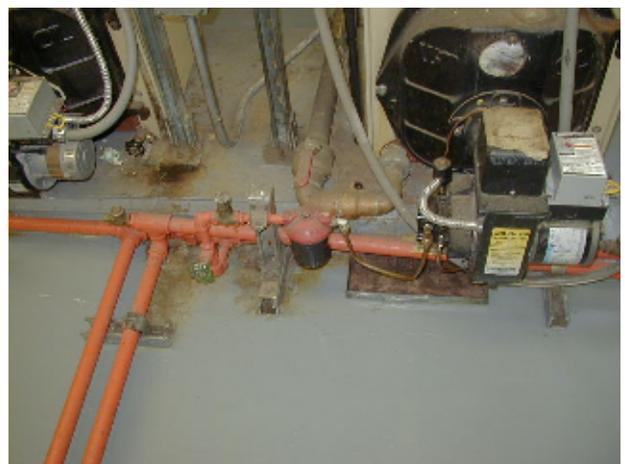
MGE20
Fuel Piping to Boilers
