BREVIK MISSION COMMUNITY HEALTH CLINIC

2003 CODE AND CONDITION SURVEY

March 1, 2004

**BREVIG MISSION
COMMUNITY HEALTH CLINIC
2003 CODE AND CONDITON SURVEY REPORT**

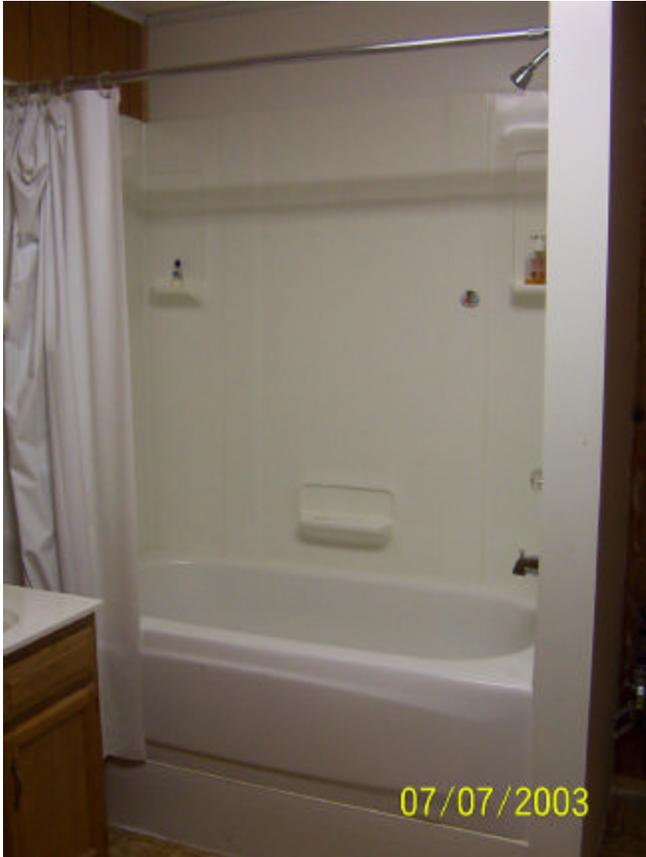
Reference Number:	A01
-------------------	------------

Description: **General Finishes in Poor Condition**

Finishes in bathroom are wood which is not easily cleanable. Tub is elevated to keep piping warm however the enclosed area does not have a grill to circulate warm air to the pipes. Existing flooring is a combination of different patterns of vinyl flooring and is deteriorated. Ceilings need paint/refinishing and are missing acoustic tiles. Attic hatch is not sealed properly.

Provide with grille to tub base. Provide new wall finishes and floor base to consist of rigid plastic sheeting, adhesive applied. Replace approximately 1200 s.f. flooring. Repaint entire building refinishing areas damaged. Replace attic hatch with insulated, tight fitting hatch.

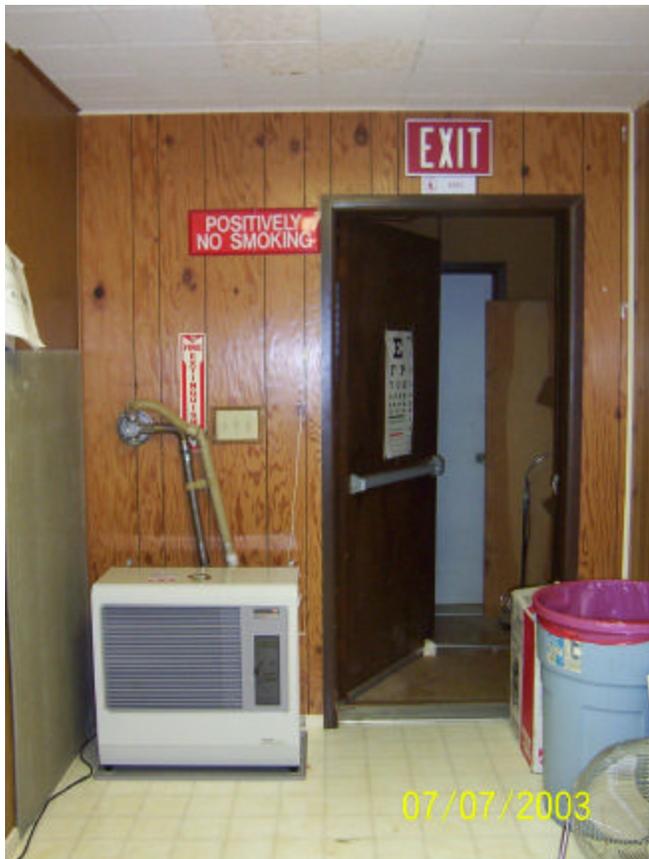
Reference Number:	A02
-------------------	------------

Description: **Rear Exit Blocked/Latched**

Rebuild back vestibule to 6' x 8'. Refer to A03 for stair replacement.

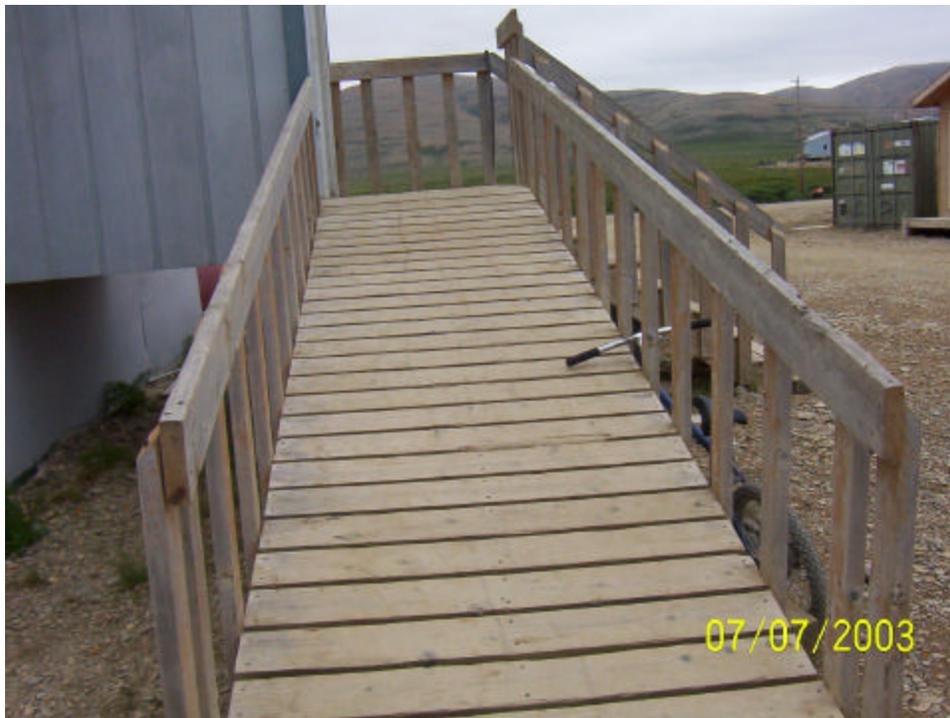
Reference Number:	A03
-------------------	------------

Description: **Accessibility Issues**

Replace stairs and ramp at main entrance, including pipe or contoured wood handrails with extensions as required by ADA. Replace all hardware with lever hardware. Replace sink with new fixture and grab-bars for tub. Reconstruct front vestibule to 7' x 8'.

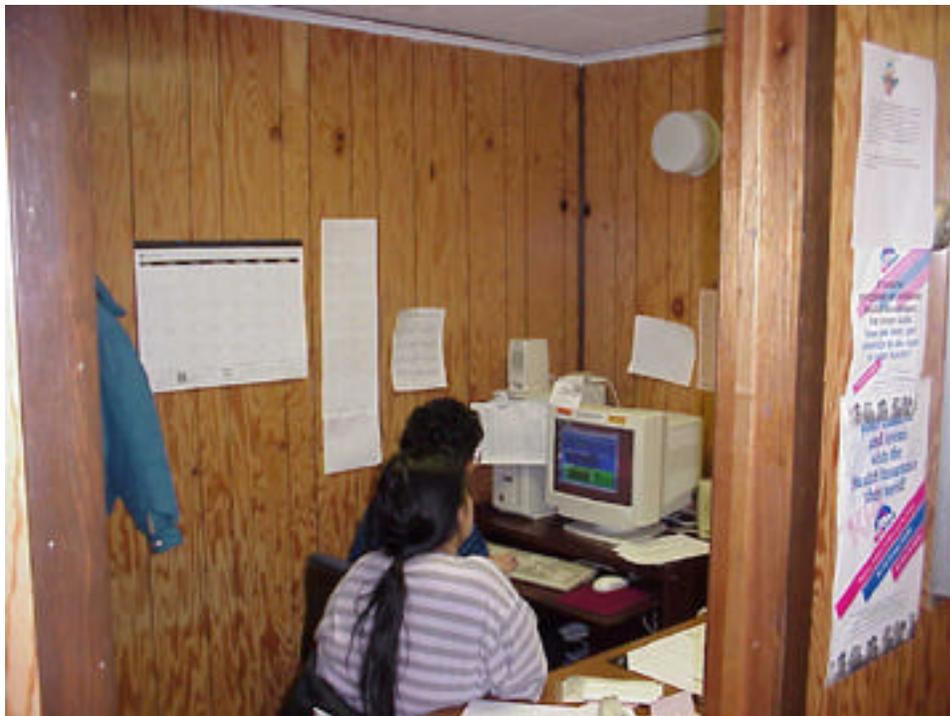
Reference Number: **A04**

Description: **Program Deficiencies**

No realistic plan to improve clinic layout. It needs to be replaced with a larger building. This estimate item is to replace all interior furnishings and casework with new medical modular equipment.

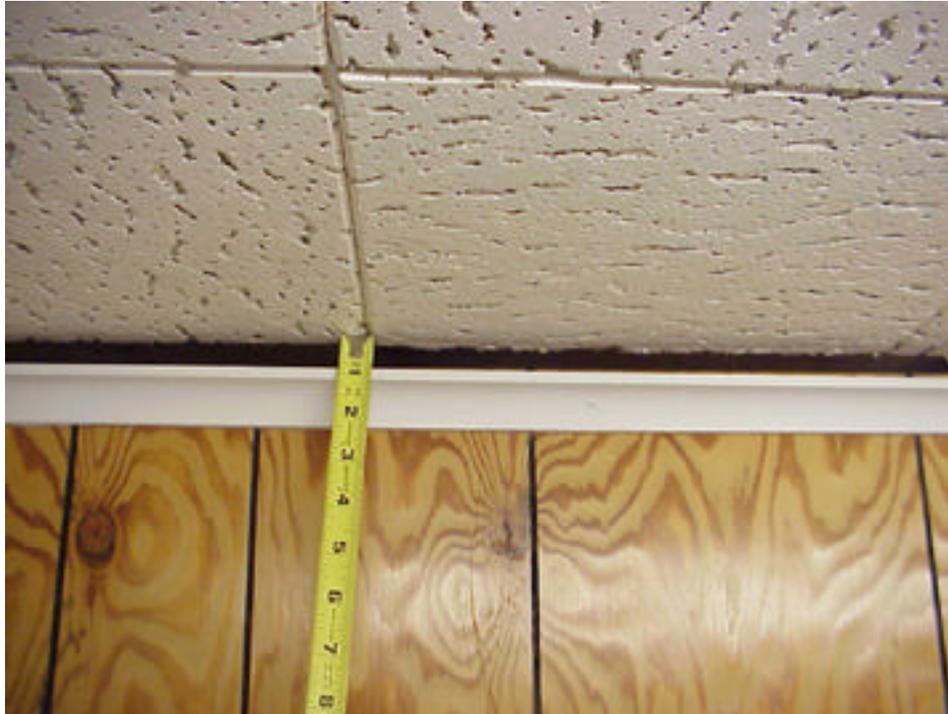
Reference Number: **A05**

The building experiences seasonal frost heaving. The 2000 visit exhibited the distortions caused by this. The current visit was late summer and most of the winter distortion was not evident. The floor has developed a moderate cross slope. Progressive settlement due to permafrost degradation, if it is occurring, is not affecting the overall framework. The building should be leveled and monitored on a seasonal basis to predict and prevent further shifting and deterioration.

Description: **Foundation Settlement**

Building settlement on seasonal frost heaving has occurred causing walls to be separated from the ceiling and other distortions of the building framing.

Replace existing foundation system with a Triodetic system. Replace front and back stairs. Replace ramp.

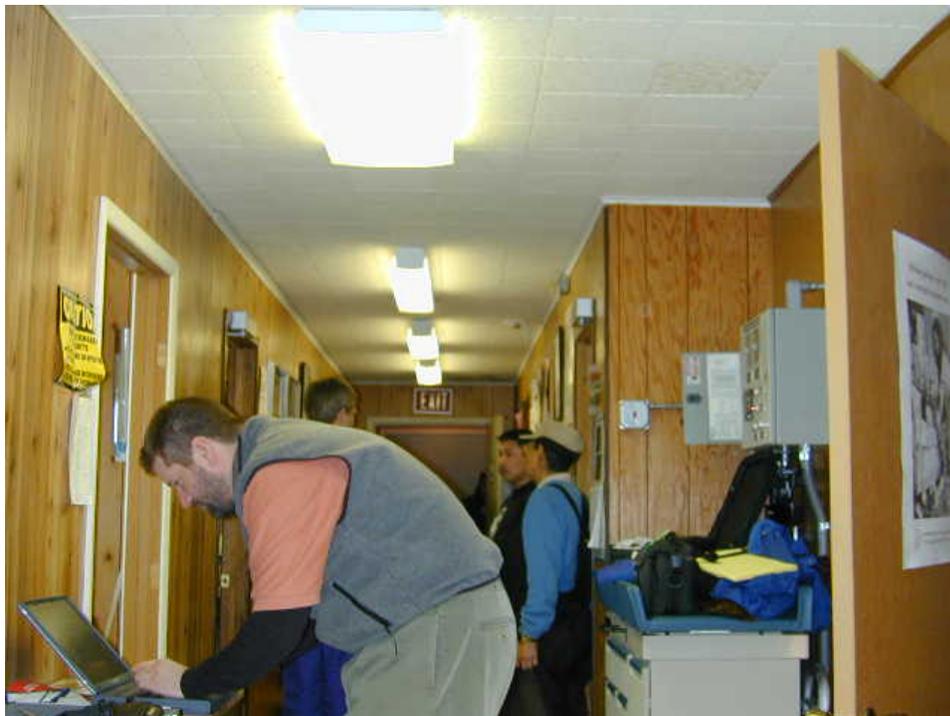
Reference Number: **M01**

Description: **Lack of Ventilation in the Clinic**

Repair the existing oil-fired furnace to provide the code required ventilation for this facility. Reuse all existing ductwork and room diffusers. A new 6"Ø duct with a manual volume damper will be required to provide outside air to the furnace system.

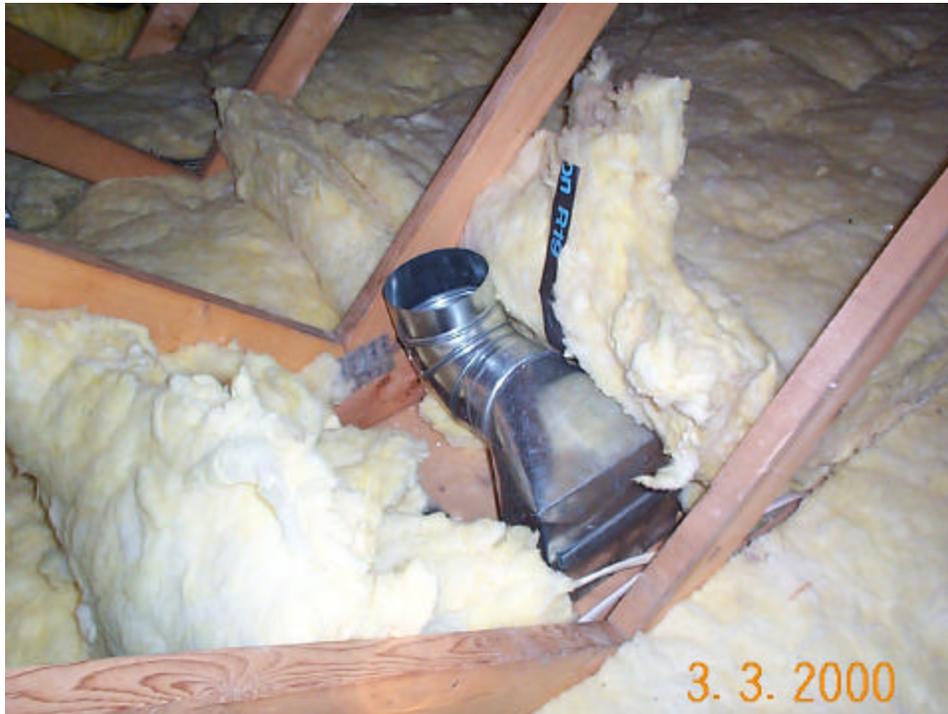
Reference Number: **M02**

Description: **Exhaust Air for the Kitchen Range Hood**

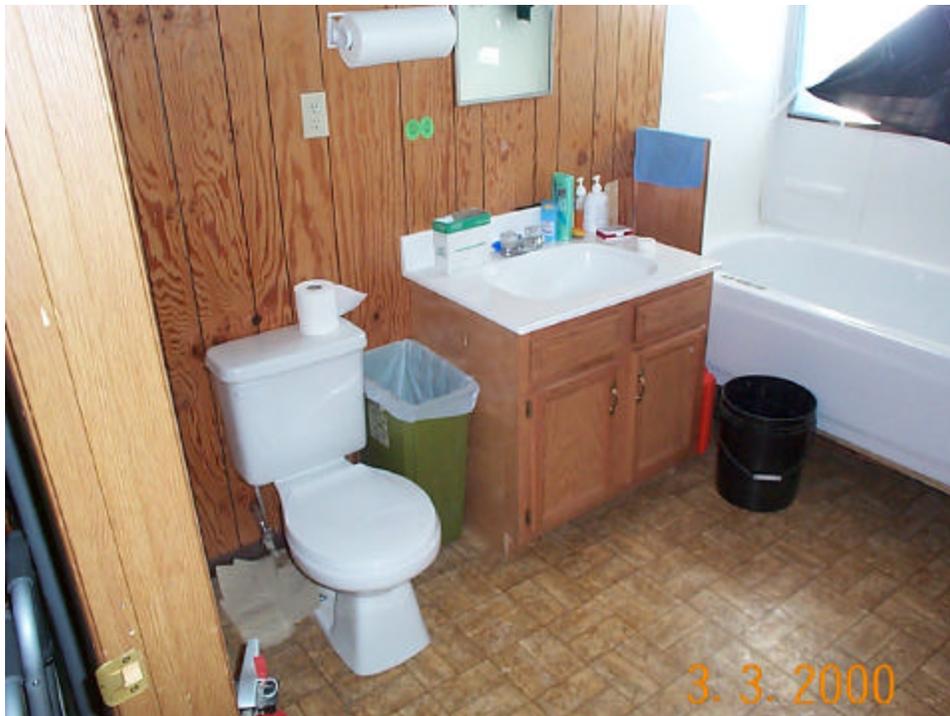
Reference Number: **M03**

Description: **Exhaust Air in Bathroom and Janitor's Room**

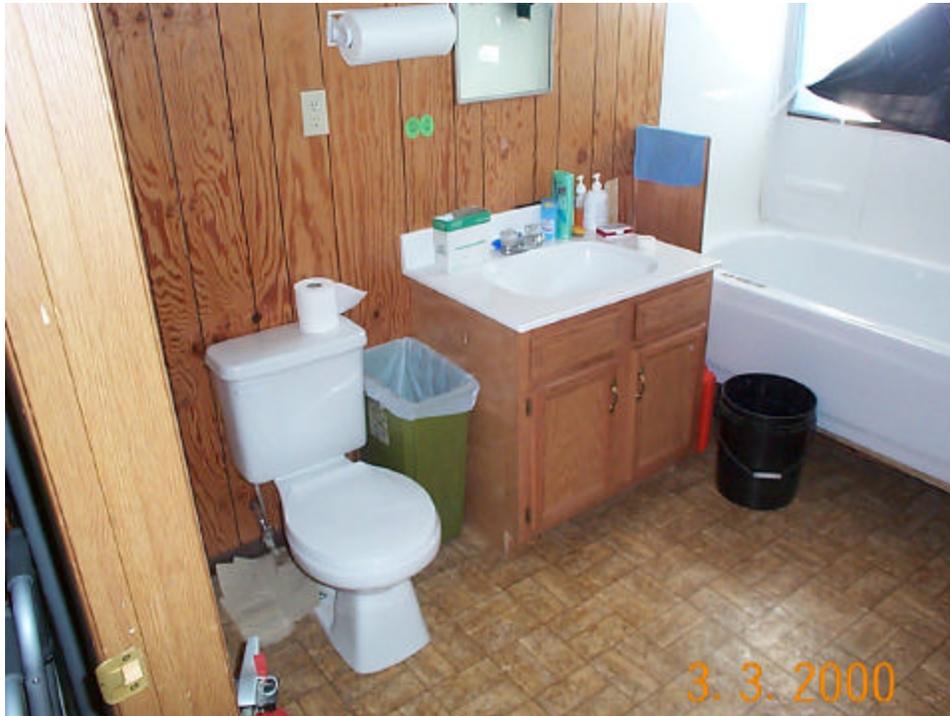
Reference Number: **M04**

Description: **Non ADA Plumbing Fixtures used in the Restroom**

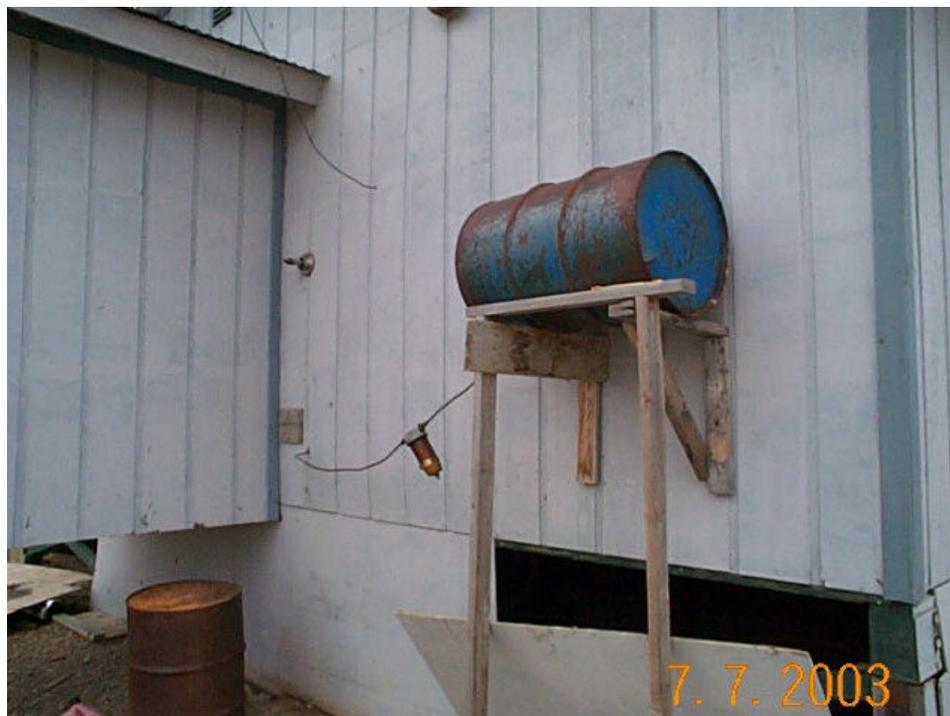
Reference Number: **M05**

Description: **Fuel Oil Storage Tank and Piping**

Repipe the monitor stove to the existing fuel oil storage tank for the furnace. This tank does meet the current codes as noted above except for valving. Route a new 1/2" supply line from the furnace tank to the monitor stove (approximately 30 ft. away). Install 1/2" isolation valves and flexible connections in the fuel oil supply and return lines at the furnace storage tank.

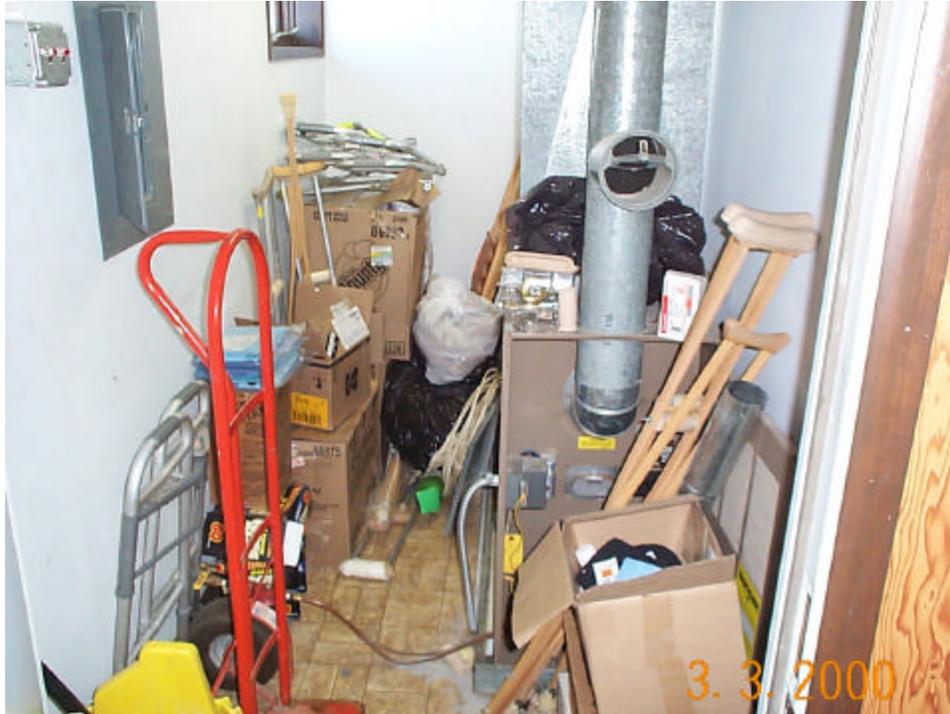
Reference Number: **M06**

Description: **Furnace Room Storage**

A large number of boxes, parts, equipment, etc. are stored in the furnace room making access for inspections, maintenance, and repair difficult (UMC section 307.1)

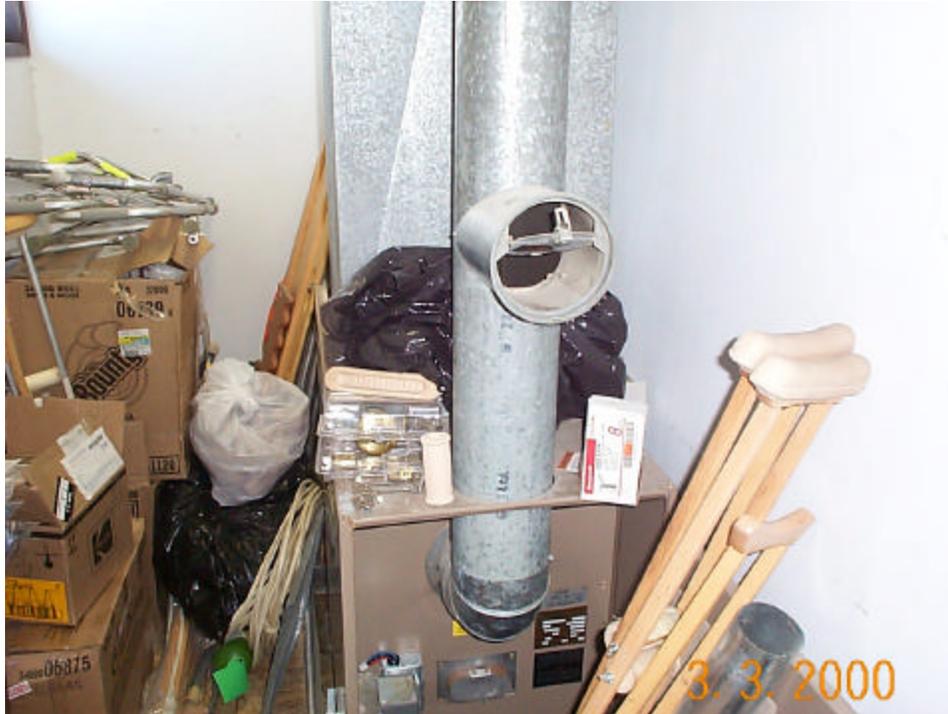
Reference Number: **M07**

Description: **Furnace Room Installation**

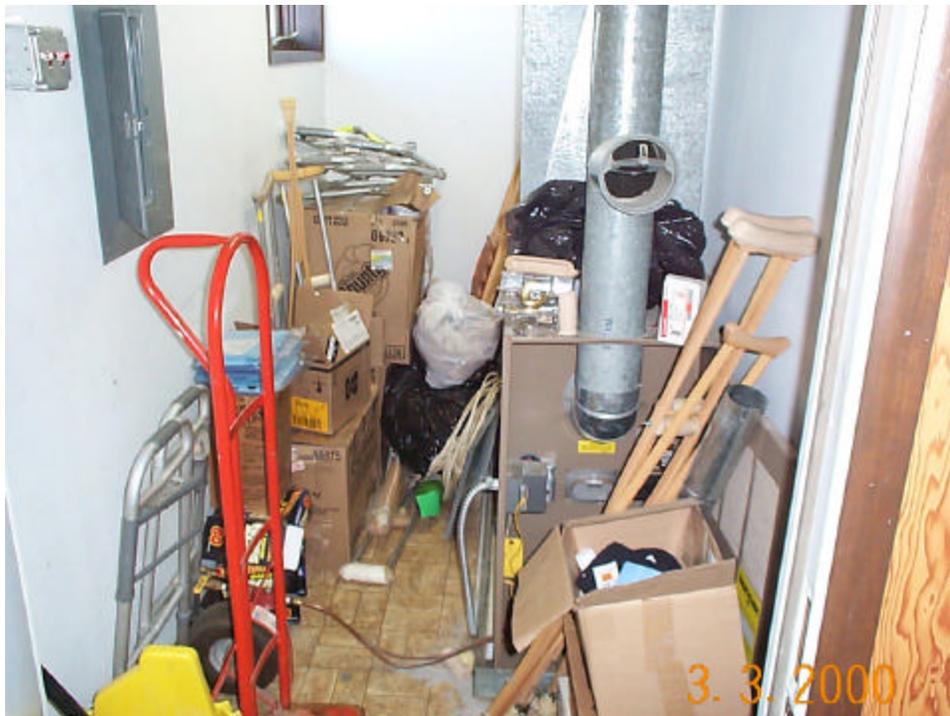
Reference Number: **M08**

Description: **Provide Combustion Air for the Furnace**

There currently is no combustion air openings for the furnace installed and not according to code (UMC section 707.1). It should be noted that this furnace is not currently being used by the clinic.

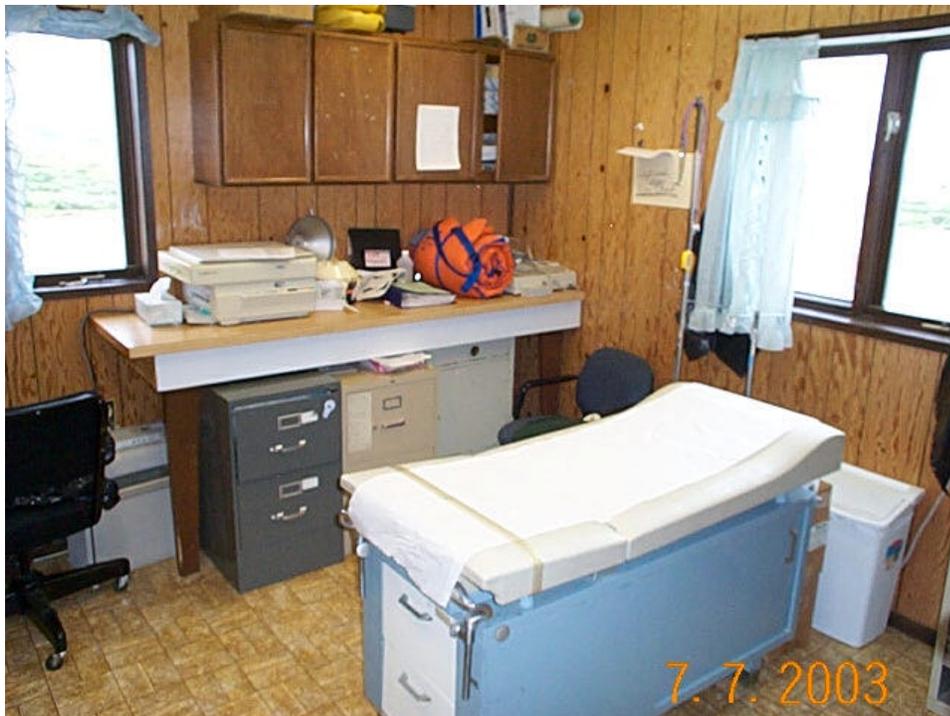
Reference Number: **M09**

Description: **No Handwashing Sink in Exam**

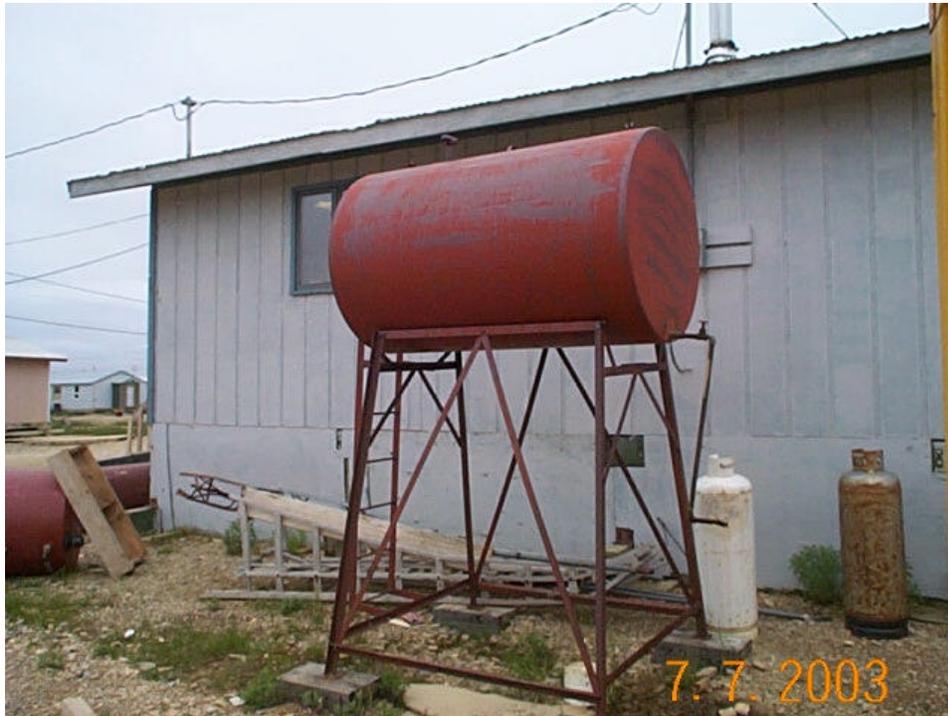
Reference Number: **M10**

The clinic's abandoned heating fuel oil storage tank is located adjacent to the building and at a minimum of 5 ft. as required by code. The 550-gallon storage tank does not have the proper valving as required by code and currently has an active leak at the drain valve.

Description: **Oil Storage Tank Needs to be Relocated**

The abandoned 550 gallon fuel oil storage tank located adjacent to the building is leaking fuel onto the ground from the drain valve.

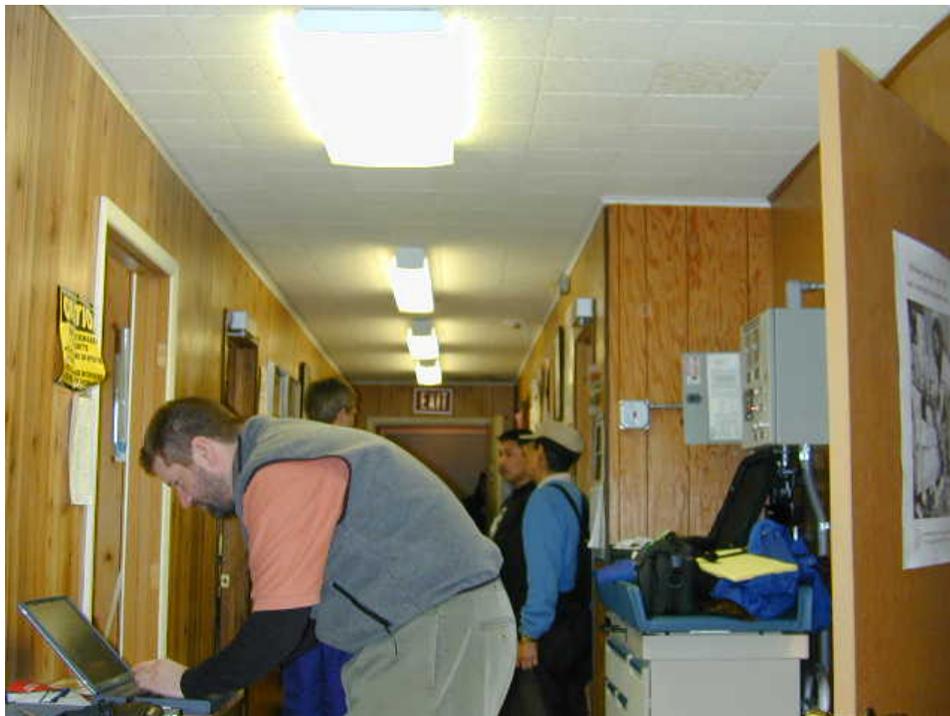
Reference Number: **E01**

Description: **Emergency Lighting**

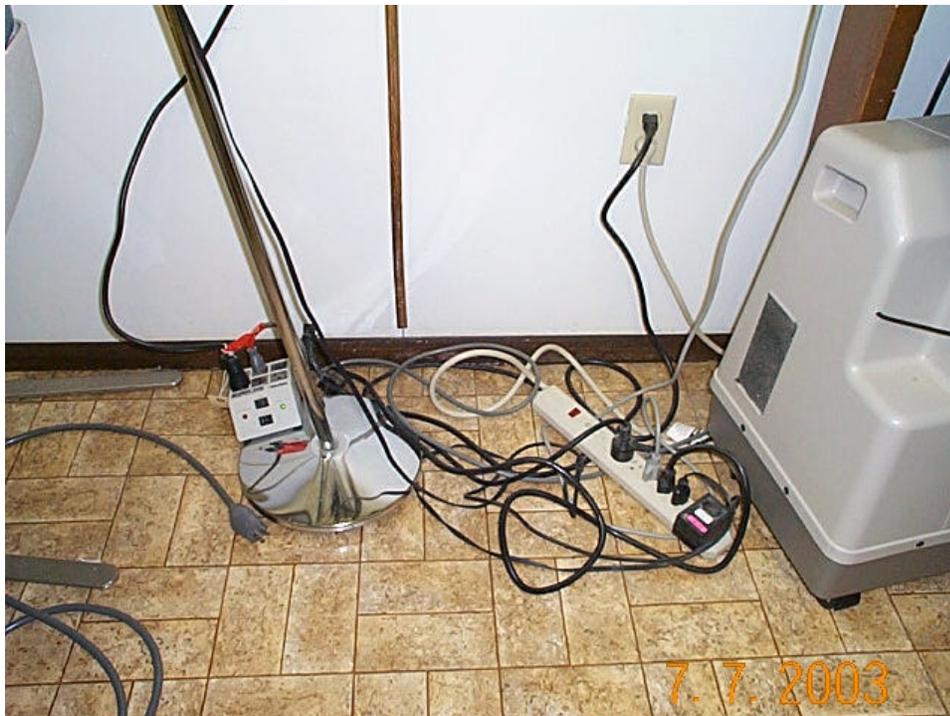
Reference Number: **E02**

Description: **Convenience Receptacles**

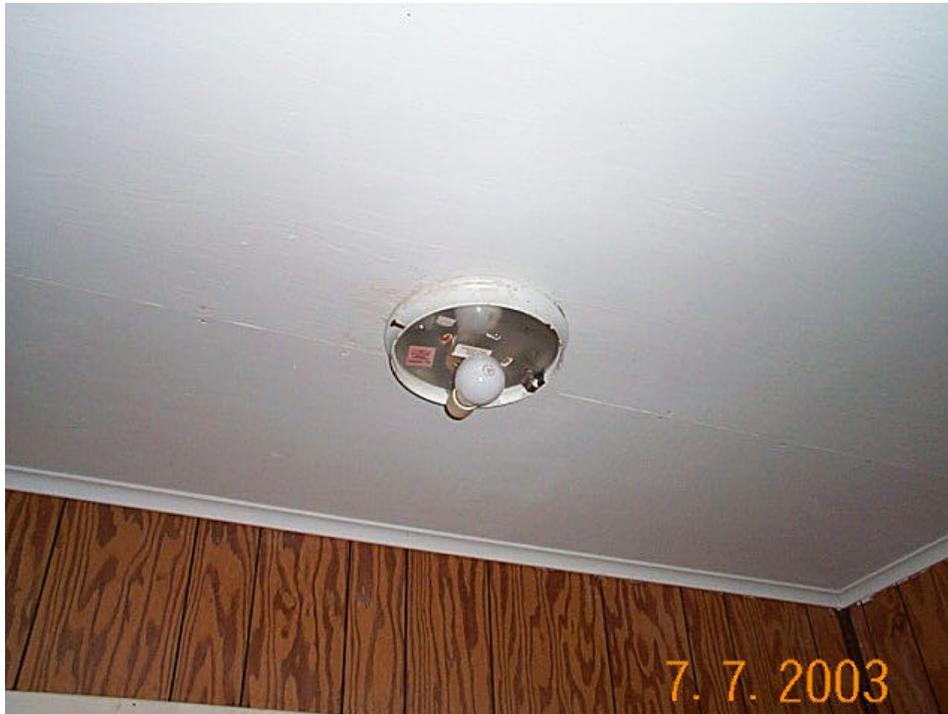
Reference Number:	E03
-------------------	------------

Description: **Light Fixtures Damaged**

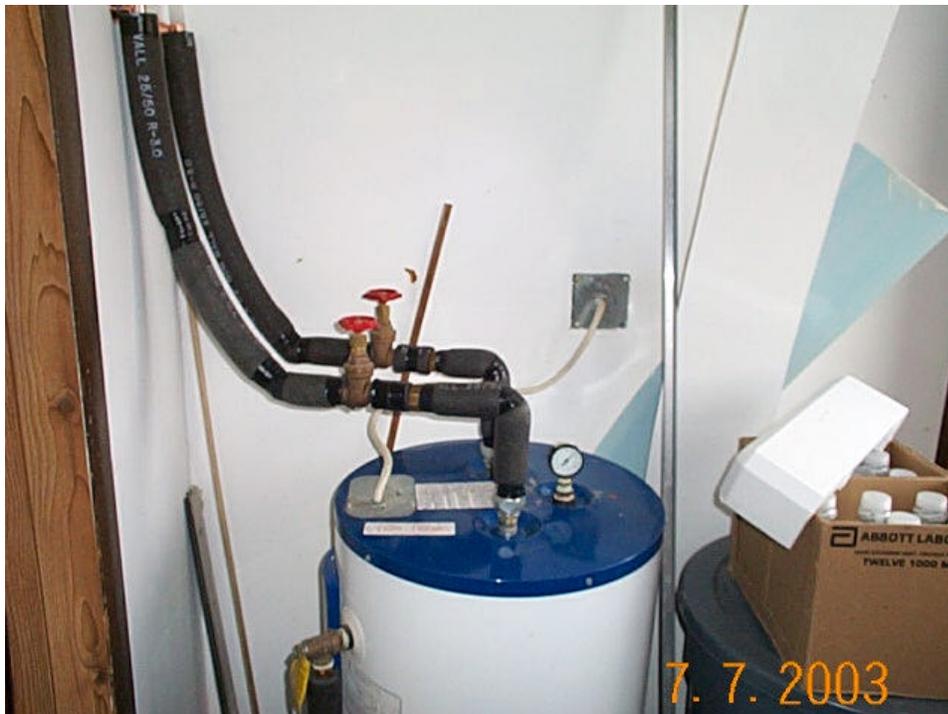
Reference Number:	E04
-------------------	------------

Description: **Exposed Wiring**

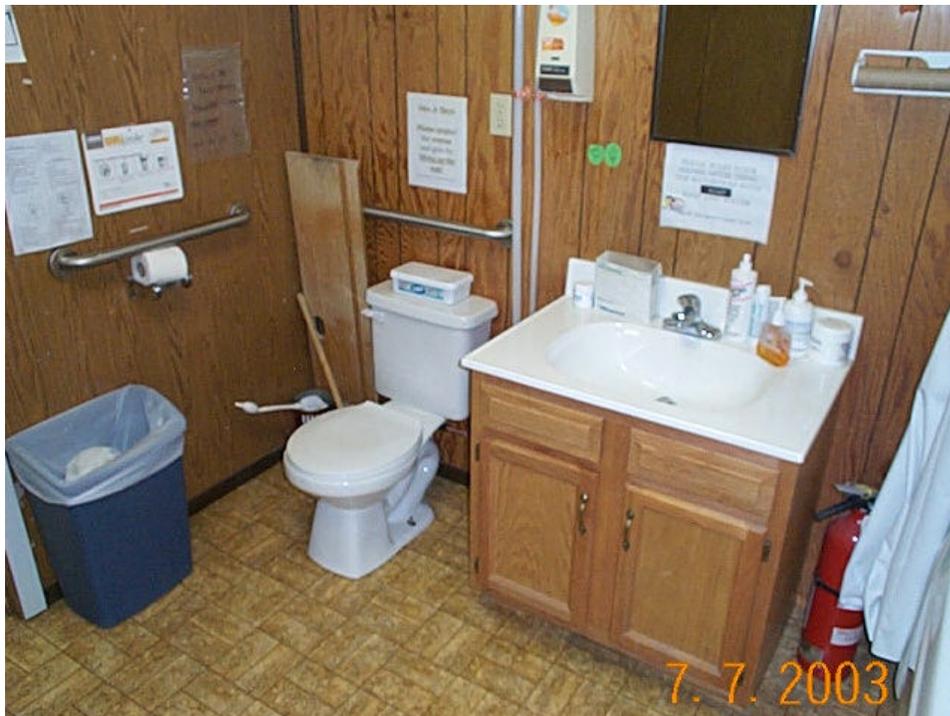
Reference Number:	E05
-------------------	------------

Description: **Provide GFCI Outlets**

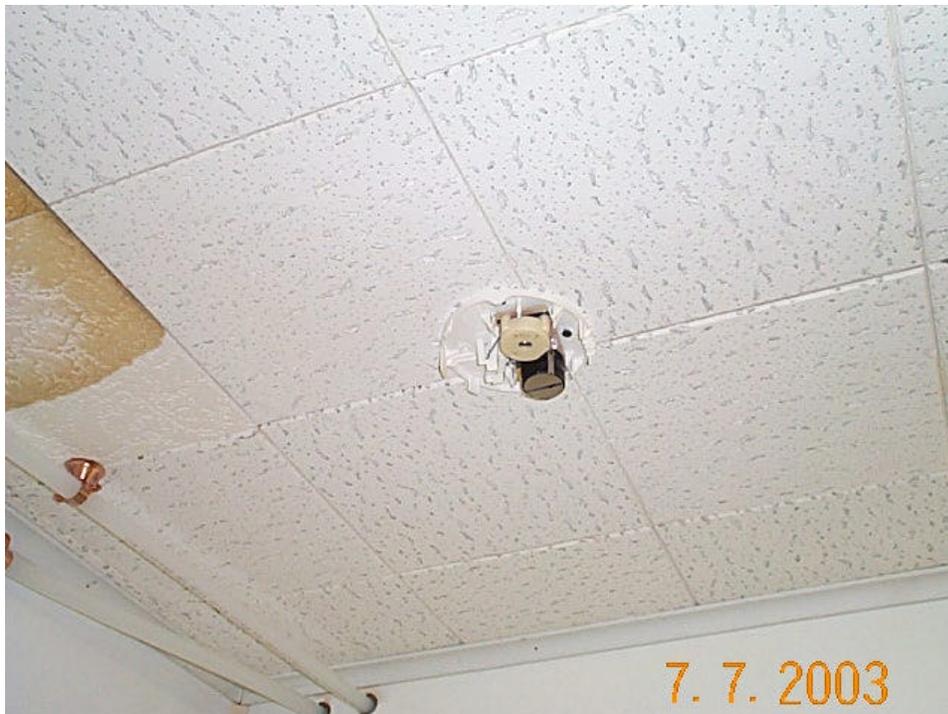
Reference Number: **E06**

Description: **Smoke Detector Inoperable**

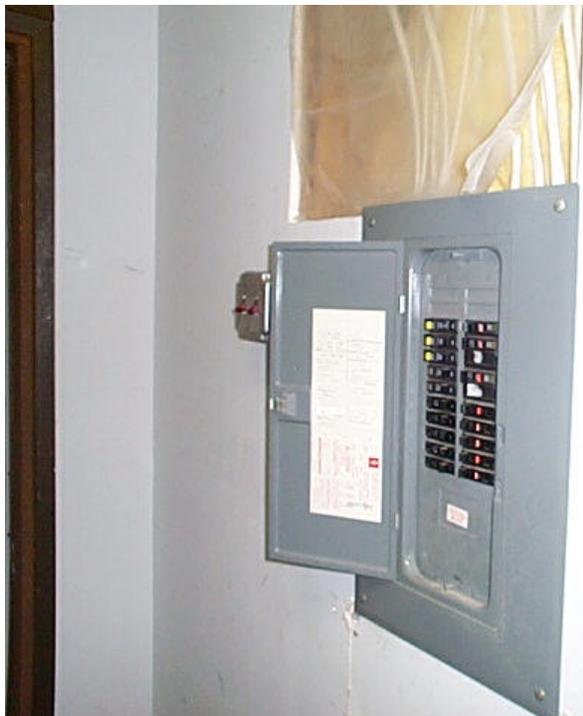
Reference Number:	E07
-------------------	------------

Description: **Panelboard Code Corrections**

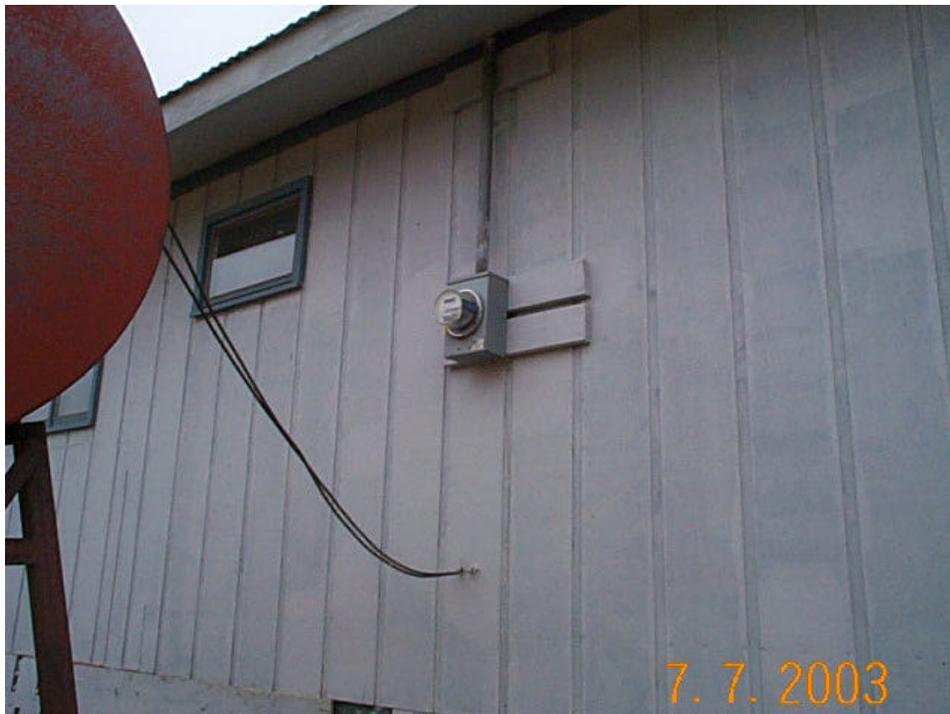
Reference Number: **E08**

Description: **Overcurrent Protection**
