Ekwok Health Clinic

Alaska Rural Primary Care Facility

Assessment and Inventory Report

December 17, 2001

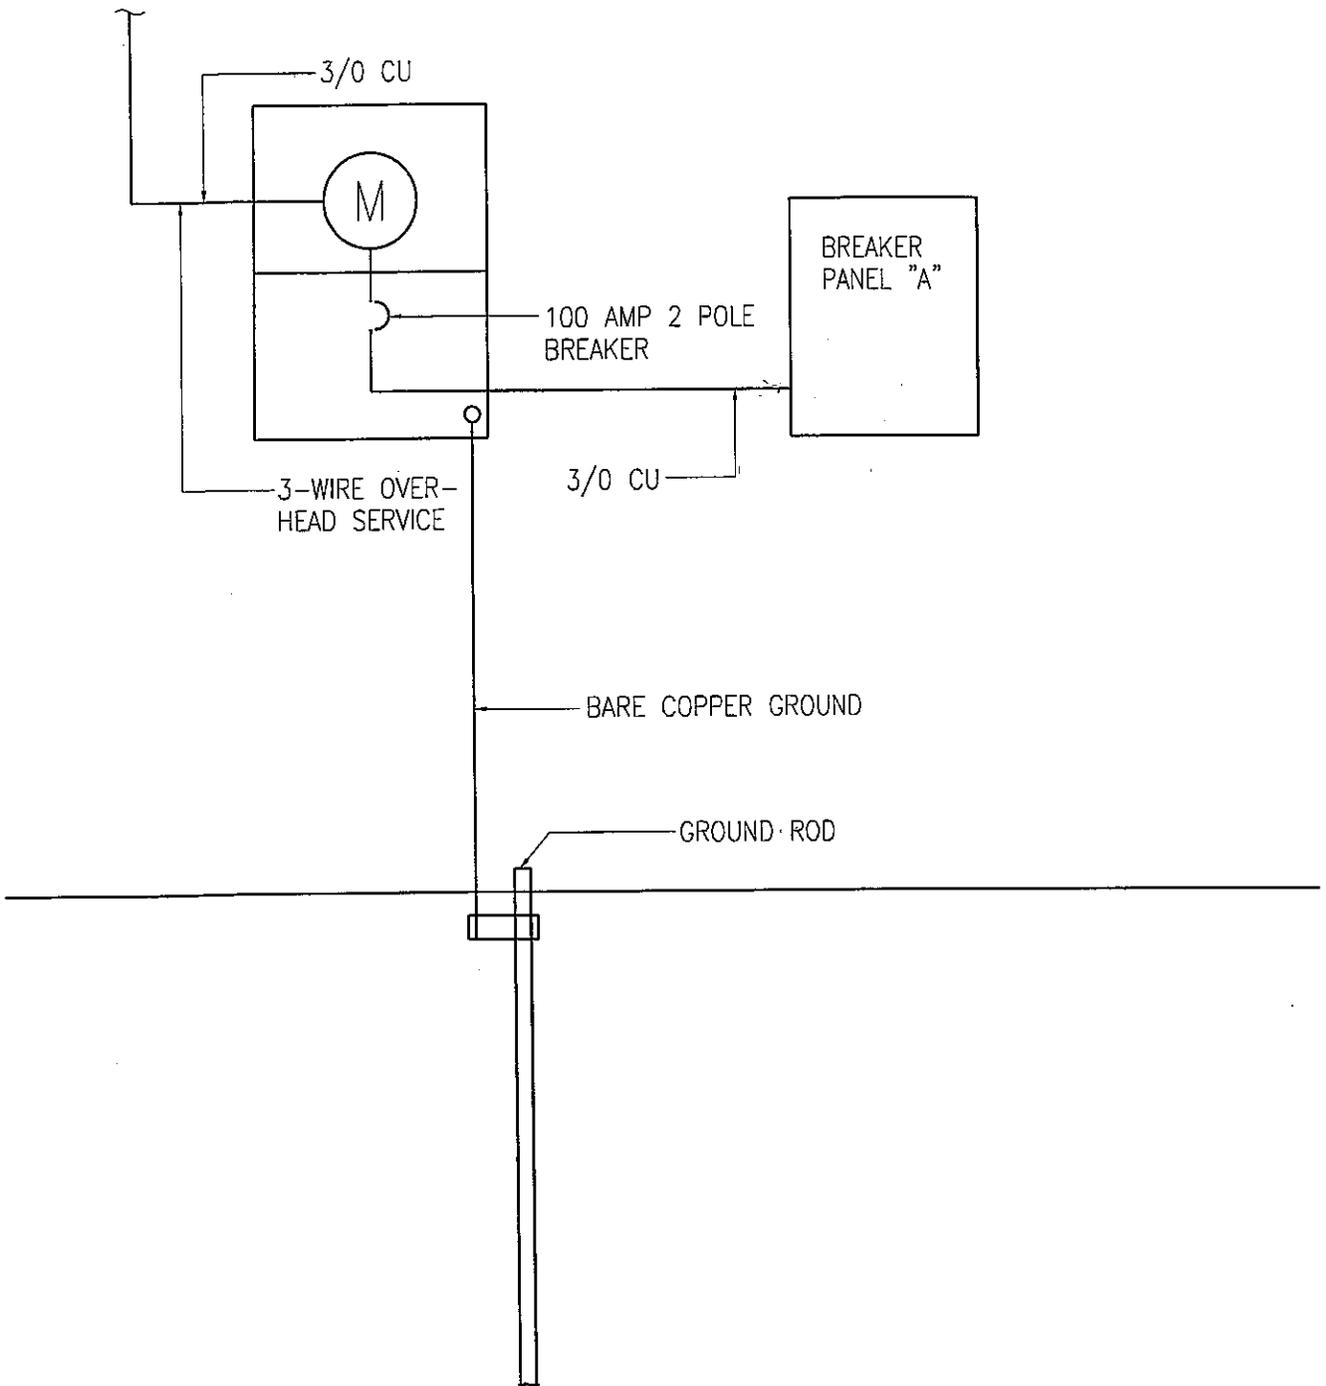
1 ELECTRICAL SERVICE ENTRANCE
NOT TO SCALE

- c. Electricity: The electrical service is provided by single overhead service to the building. The service extends over the roof of the building less than eight feet above the roof (not conforming to NEC). The main disconnect is located at the meter. The building is served with 3/0 copper conductors and neutral. A number of deficiencies are noted in the Electrical Narrative.

disconnect is located at the meter. The building is served with 3/0 copper conductors and neutral. A number of deficiencies were noted with respect to the electrical service.

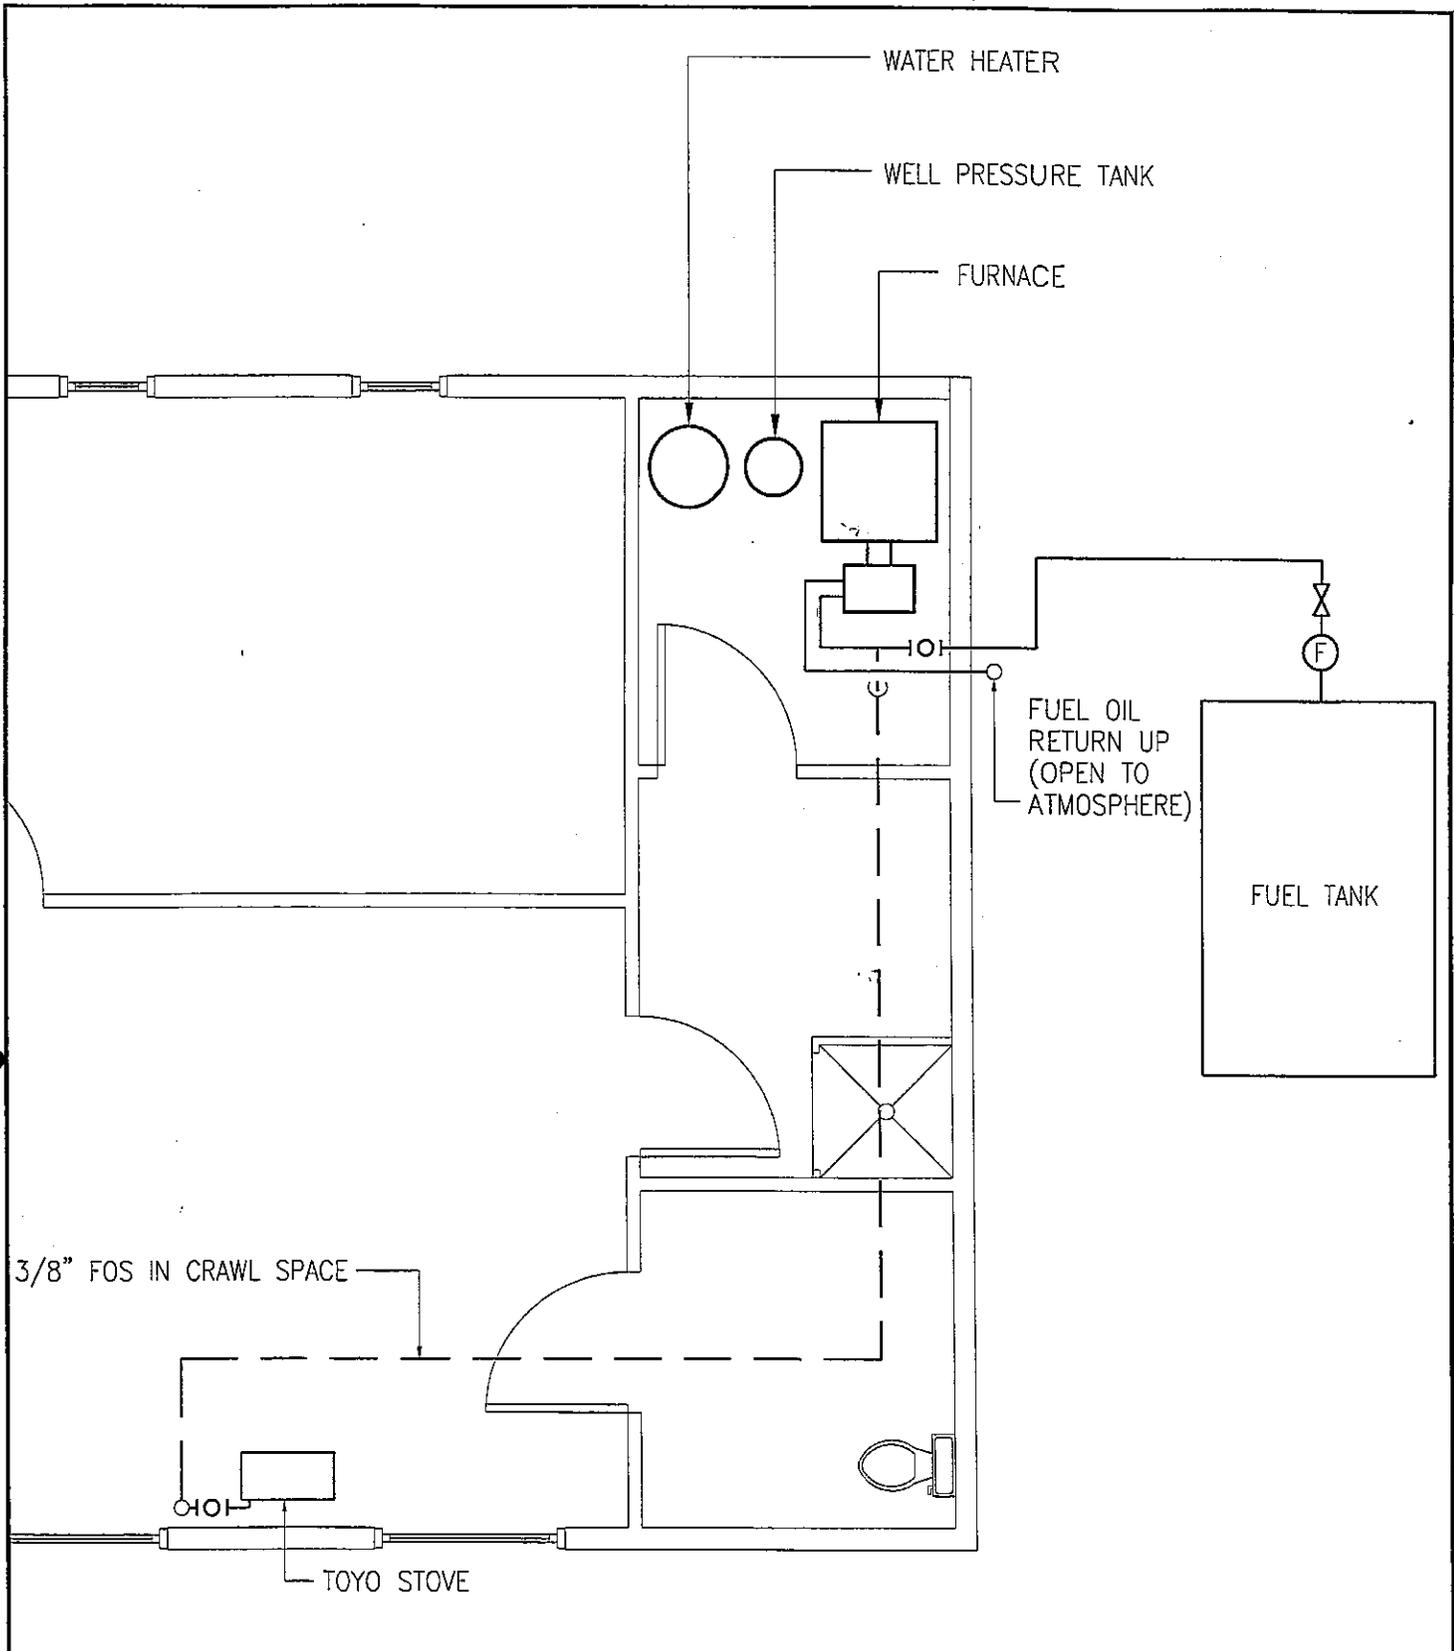
1 PARTIAL MECHANICAL PLAN
 1/4"=1'-0"

- b. Furnace: A single residential grade oil-fired furnace located in the mechanical room provides primary heating to the facility. The furnace was inoperable at the time of inspection. We were informed that a "vapor lock" had occurred in the furnace, though the system was typically reliable. The vapor lock problem would likely be resolved if a Tiger loop were installed in the fuel oil supply to the burner. The furnace has a ducted supply with ductwork running through the crawlspace. Supply air diffusers are installed in each of the perimeter rooms and appear to be well distributed. Return air is ducted in steel ductwork from a grille located in the waiting area of the clinic through the attic and back to the furnace. No provisions have been made to allow outside air to the furnace. All air is continuously re-circulated through the furnace when the thermostat calls for heating. Combustion air was designed for the room using upper and lower 4" drier vents into the mechanical room. Unfortunately the drier vents have been equipped with back draft dampers that do not allow combustion air to function properly. For the system to meet code, the dampers must be removed. Specific code deficiencies are listed in the deficiency report.

- a. Supply Air System: The furnace does not have an outside air intake, and is not providing ventilation to the building. All air is re-circulated through the furnace. Operable windows are the only method of ventilation for the clinic. Ventilation requirements will not likely be met in winter, as windows are typically kept closed unless cooling is required. We recommend designing and

installing a positive ventilation system using an air handler unit or providing an outside air intake into the furnace if the system is heated using a furnace. We don't recommend installing outside air capability to the existing furnace system since the amount of outside air required would likely reduce the temperature of air passing over the heat exchanger to a temperature that may result in condensing or crack the heat exchanger.
