TRIP REPORT

VILLAGE SAFE WATER

LOCATION: Emmonak, Alaska **PROJECT NO:** N/A

Subject: Post-Construction Performance Evaluation
New Washeteria Building
Emmonak, Alaska
DM&A Job No. 4135.006

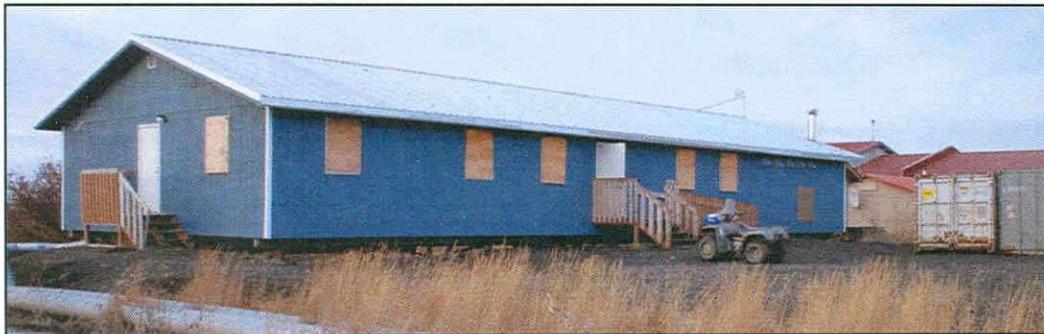
Figure 1. View to the southwest of new washeteria building from Emmonak Road

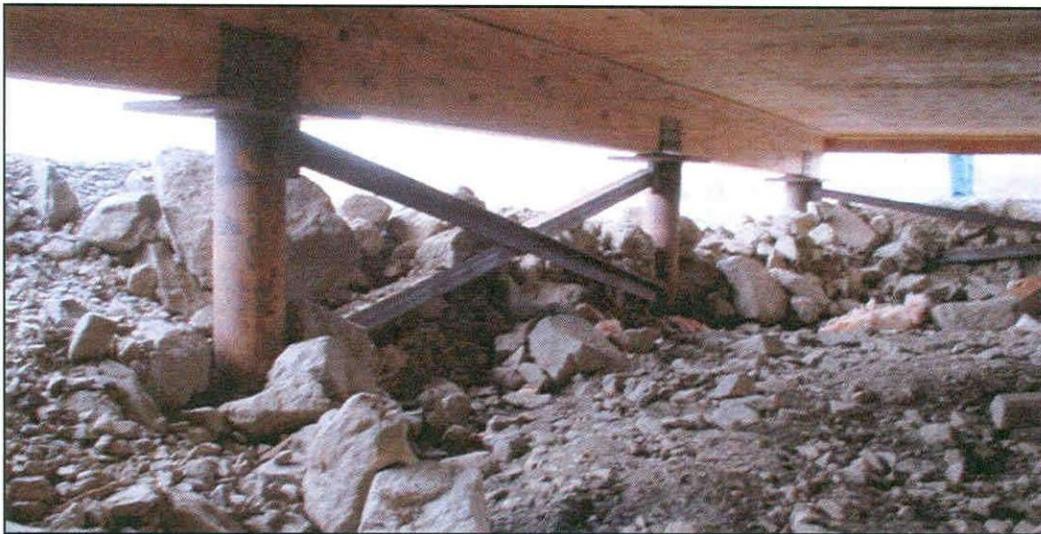
Access from Emmonak Road and customer parking is provided by a granular fill pad north of the washeteria. The fill limits extend to the building eaves along the north side of the building and approximately half way along the east and west sides. The toe of the fill embankment in these areas extends underneath the building and around the pile supports as shown in Figure 2. In some areas, large cobbles and small boulders are in contact with the diagonal bracing. The total thickness of the fill ranges from 1.5 to 3 feet along the building eaves.

Figure 2. Parking area fill placed against the north pile supports and cross bracing (center) and east pile supports and cross bracing (right).

- Remove the parking area fill and loose rocks from around the pile supports and cross bracing along the north, east, and west sides of the building. Reestablish the fill pad such that the toe of the embankment does not extend to the piles under the building. The embankment shoulders should be sloped at 1.5 horizontal to 1 vertical (1.5:1) or flatter.

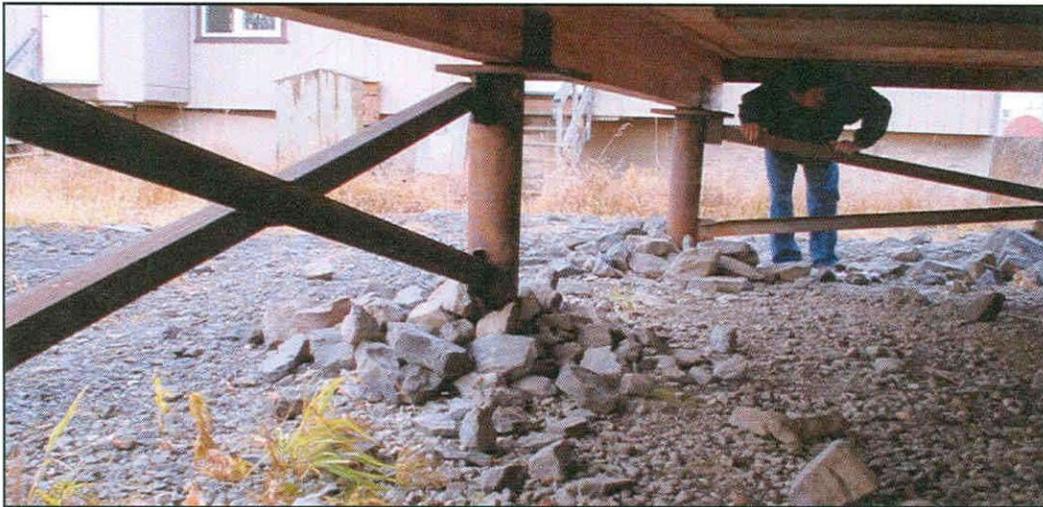
Figure 3. Perimeter cross bracing and loose debris around the pile supports at the southwest building corner.

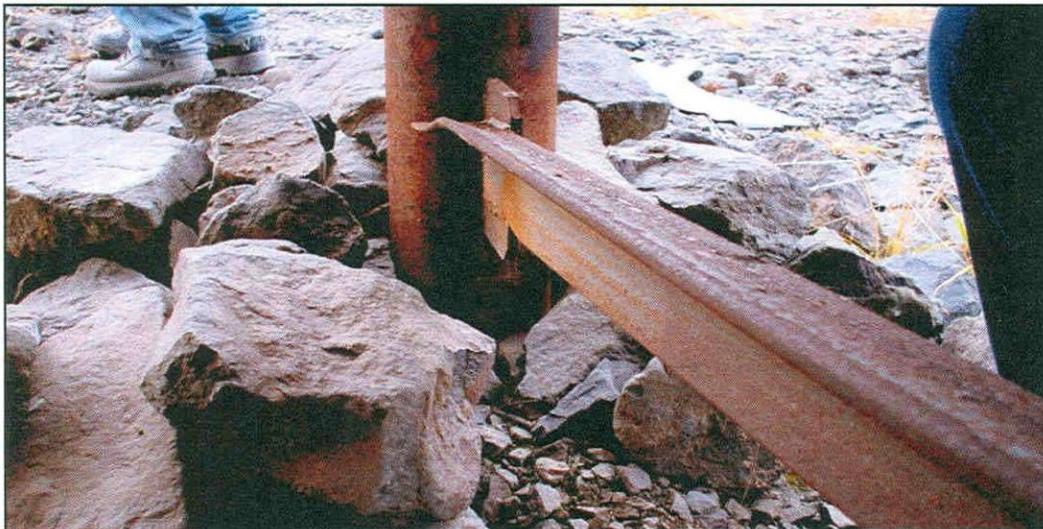
Figure 4. Typical appearance of damaged cross bracing (southwest corner).

The bottom edges of the cross bracing appeared damaged at several locations along the perimeter. At the time of our visit, loose rocks were observed beneath the cross bracing at each of these locations. We expect the rocks engaged the bracing in these areas in the past as the surficial soils heaved due to seasonal frost action. Figure 4 shows an example of the cross bracing damage typically observed. The locations where damaged bracing was observed are at areas where up to 1-inch of uplift was measured.

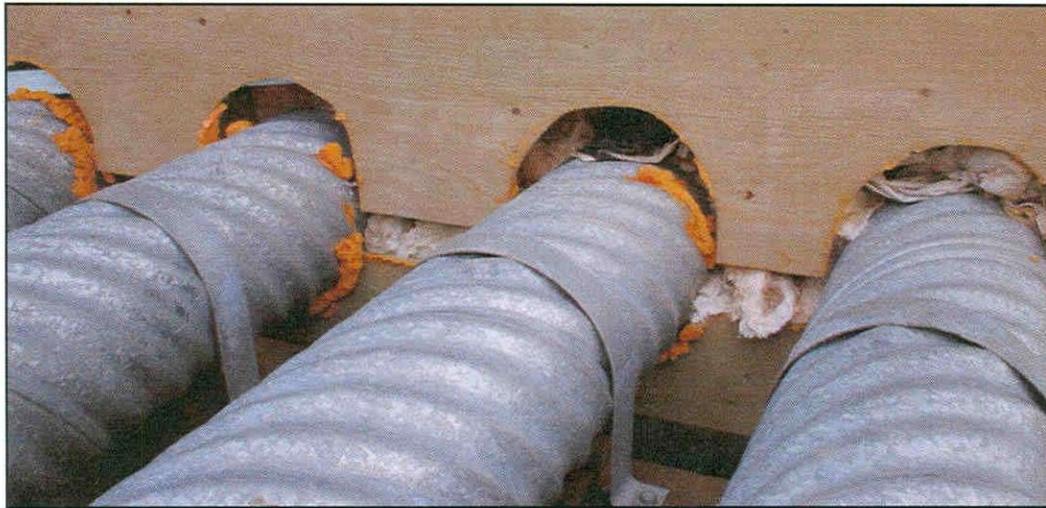
Water and sewer service is provided by above ground insulated pipes which enter the washeteria through a plywood utility enclosure under the southeast corner of the building. We observed evidence of approximately 2 to 3 inches of previous displacement where the pipes pass into the enclosure (Figure 5). The enclosure is accessed from the interior of the building and contains the water supply and wastewater manifolds. We assume the enclosure is insulated. We do not know if the pipes have a flexible connection where they enter the building. Most of the walls of the enclosure were in contact with the ground beneath the building at the time of our visit. This type of enclosure is typically suspended from the floor beams or joists and designed to provide enough clearance between the bottom of the enclosure and the ground surface to avoid interference caused by seasonal ground motion associated with frost heave.

Figure 5. Separated plywood at arctic pipe penetrations into utility enclosure (SE corner).

Both the water and sewer pipes entering the building and the utility enclosure itself have been subjected to vertical uplift loads associated with seasonal frost action and these loads have been transmitted to the washeteria floor in the southeast corner of the building. In addition, where the pile supports and cross bracing are either partially buried by granular fill or surrounded by loose cobbles and boulders, seasonal ground motion has resulted in damage to some of the cross bracing and uplift loads on the piles. If the fill and loose rocks are left in place, these piles may experience additional displacements in the future. We recommend relieving the potential for vertical loading in the future at each of these areas of concern. Specific recommendations include:

- Lower the existing grade below the utility enclosure by manually excavating material so that at least 6 inches of clearance is provided below the enclosure at all points. Care should be taken to maintain positive drainage so that surface water runoff does not collect underneath the enclosure or around nearby piles.
- Provide an allowance for seasonal movement of the water and sewer pipes. This may be accomplished either by locating the supporting timber cribbing further from the enclosure or designing flexibility into the pipe penetrations and connections inside the enclosure.
- Manually remove the loose cobbles and boulders from around all piles and cross bracing along the south side of the building so that future ground motion will not cause interference with the above grade support structure. Provide at least 6 inches of clearance under the cross bracing.

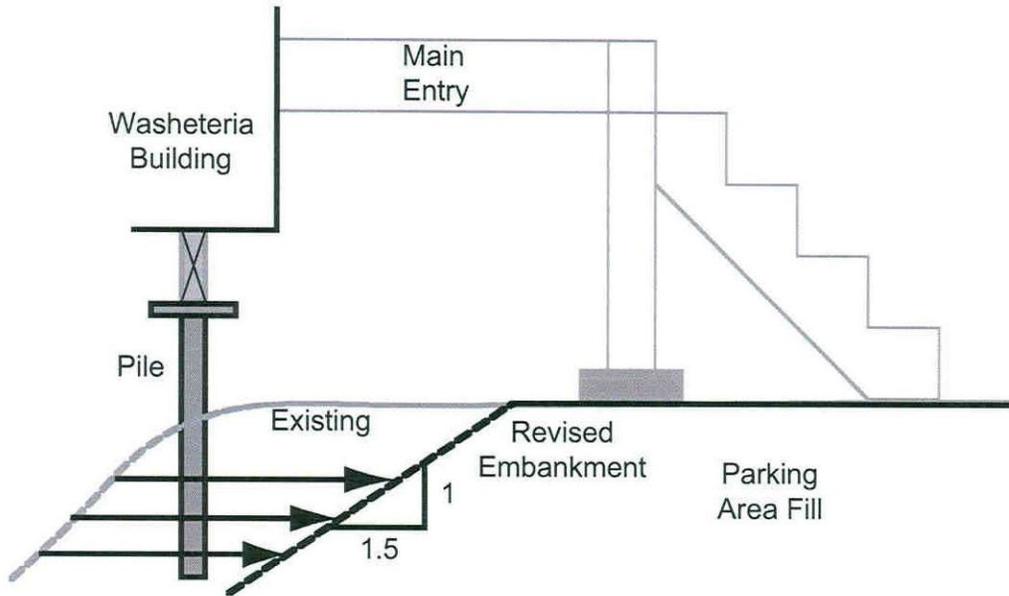
Figure 6. Revised cross section for parking area fill pad embankment.

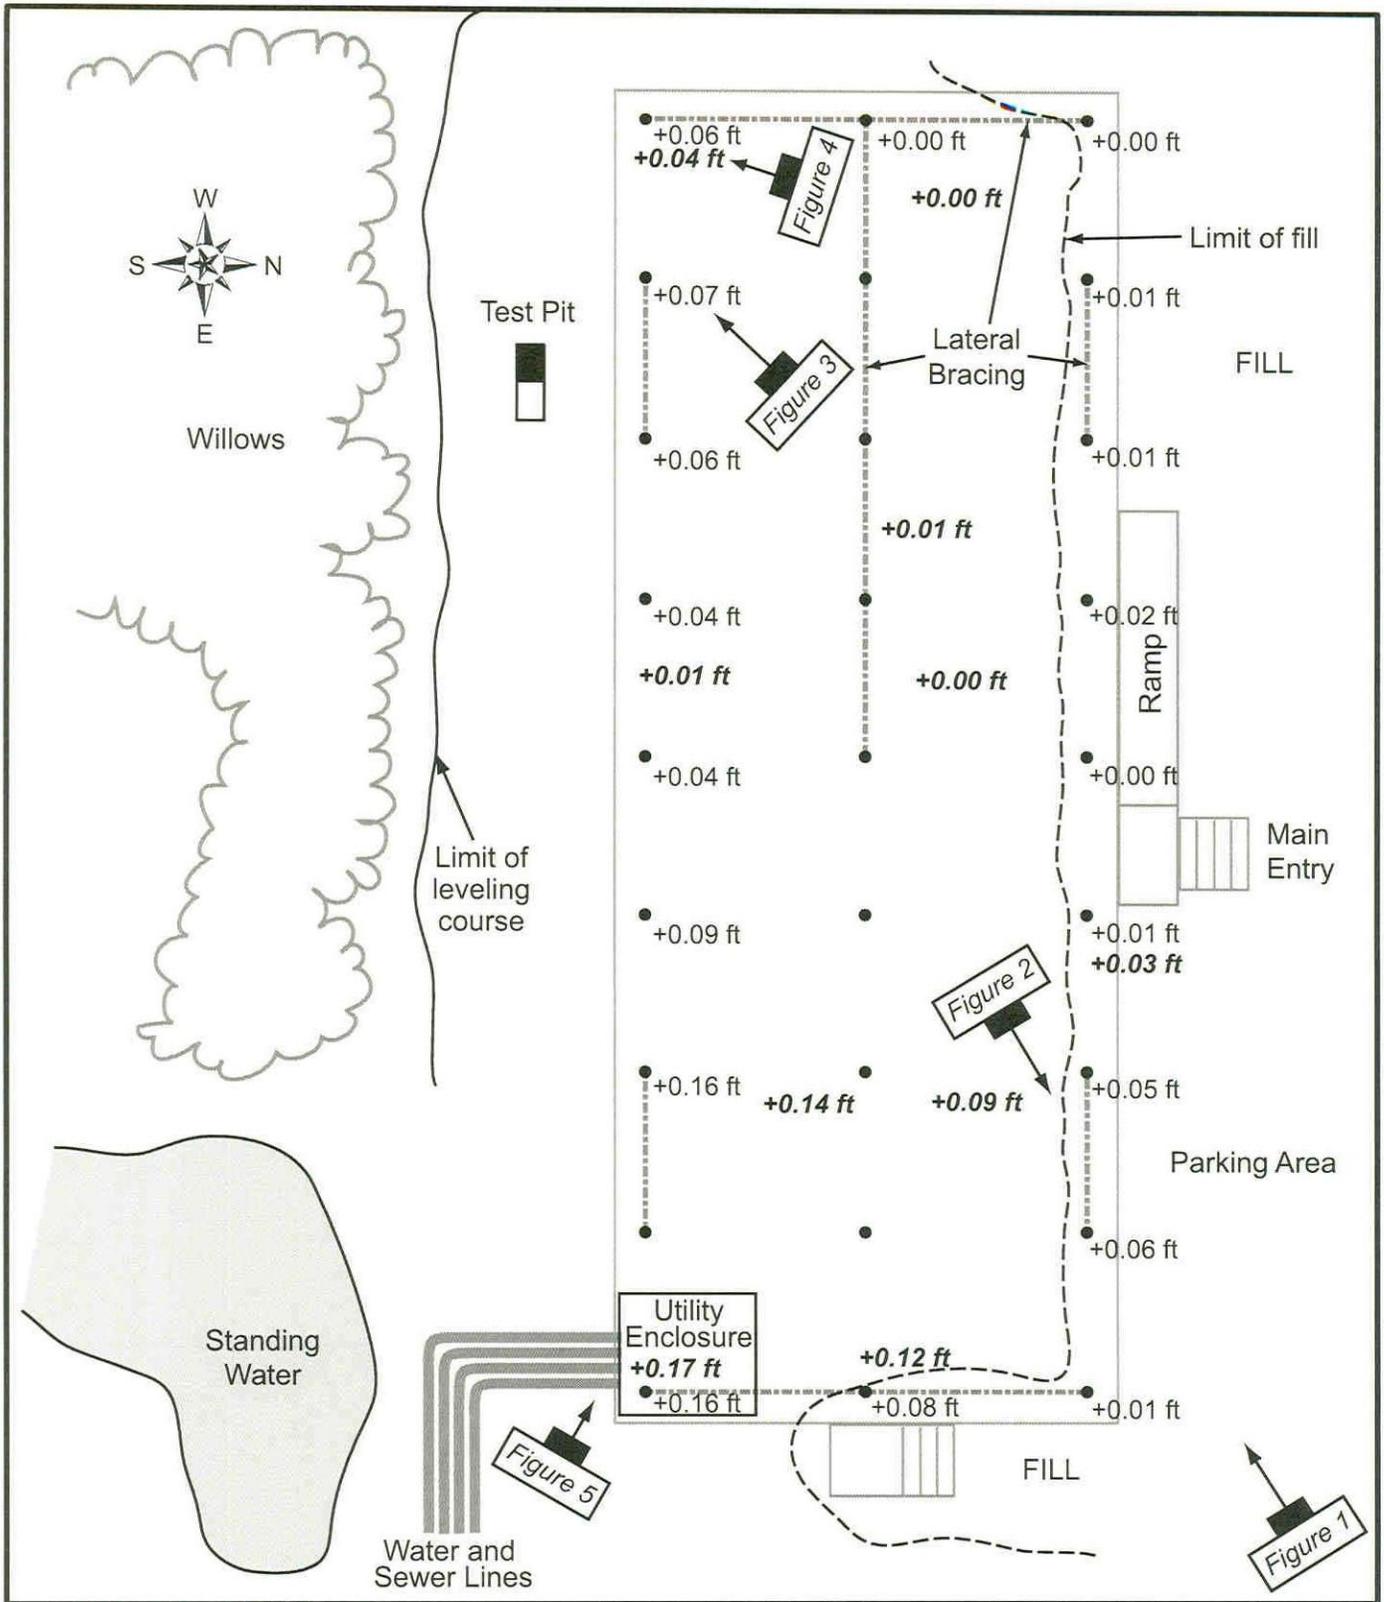
SITE LAYOUT and PHOTO KEY
New Washeteria Building
 Emmonak, Alaska

interior finish floor heights were also measured for comparison. Both surveys indicate the southeast corner of the building is approximately 2 inches higher than the rest of the building areas. The survey results are shown on Plate 1.
