FABRICATION INSPECTION REPORT

Project: Knudson Cove Harbor	Report No: Mantle - 001
File No : 062010.05	Date: October 22, 2008
Consultant: PND Engineers, Inc.	Day of the Week: Wednesday

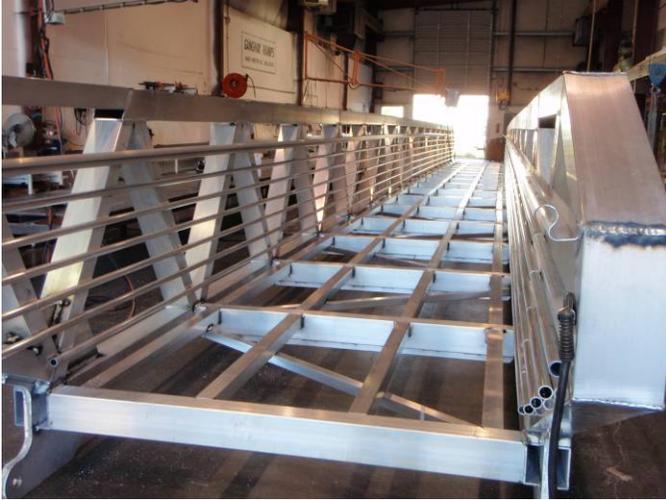
Photograph No. 1

80' gangway laid out inside the fabrication shop.

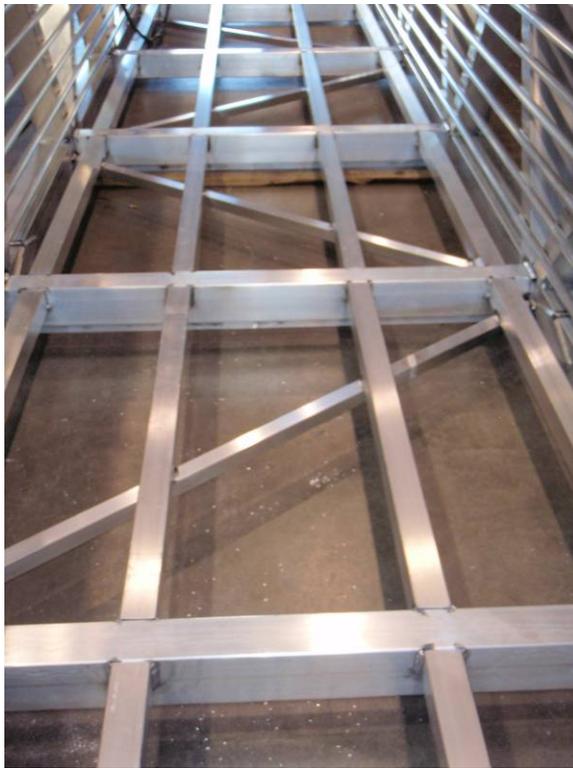
Photograph No. 2

Typical framing underneath the walkway.

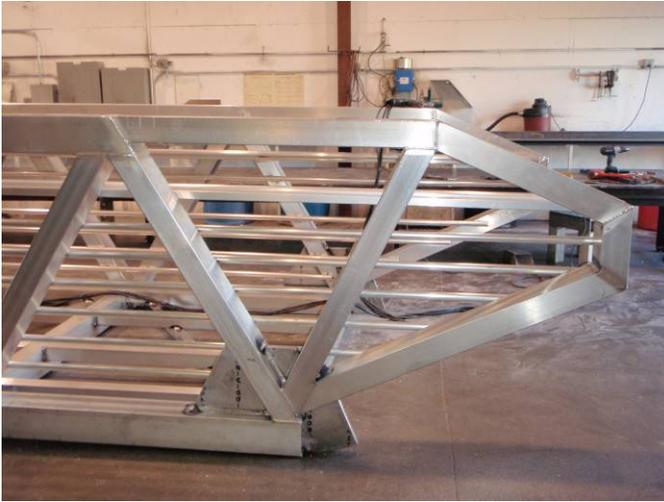
Photograph No. 3

Gangway end.

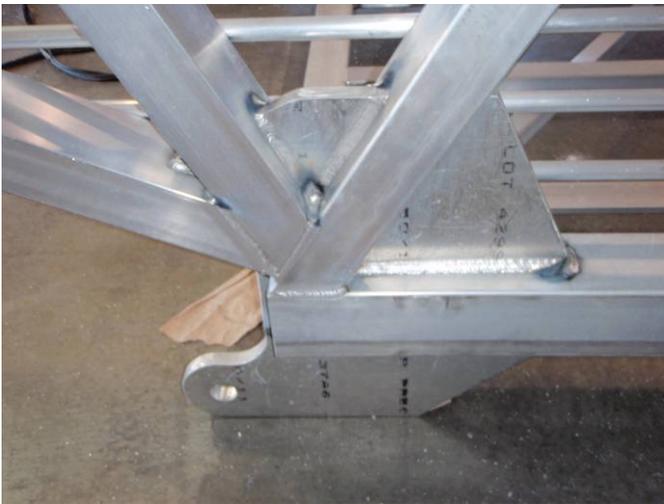
Photograph No. 4

Hinge gusset plate installed as one, uniform piece.

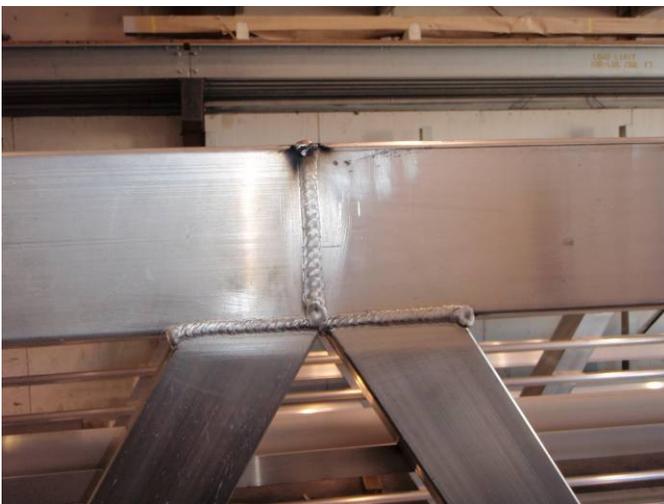
Photograph No. 5

Typical top chord splice.

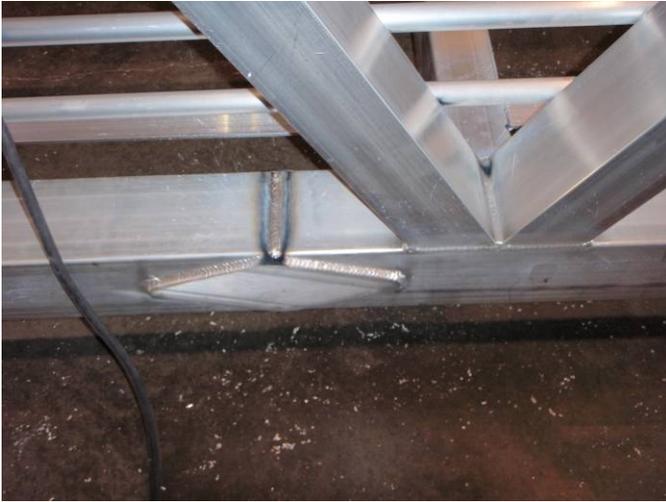
Photograph No. 6

Typical bottom chord splice.

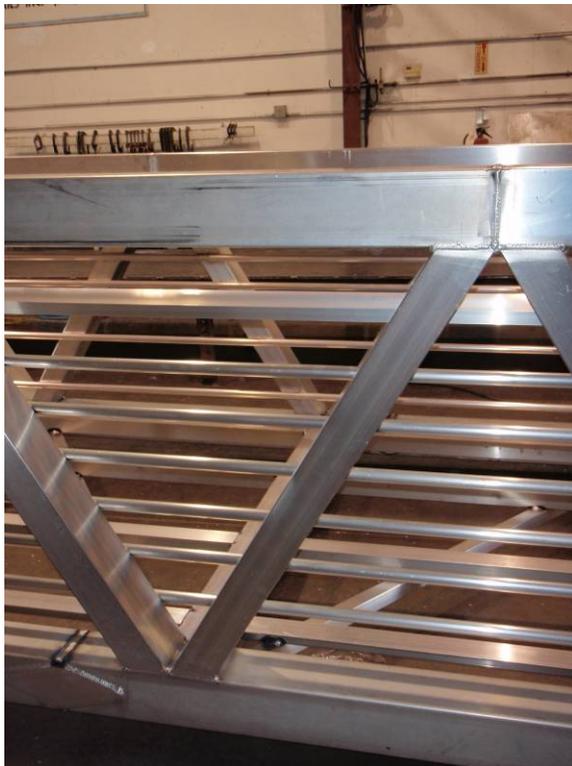
Photograph No. 7

The top and bottom chord splice joints were observed to be offset on the same side and staggered comparatively to the opposite side.

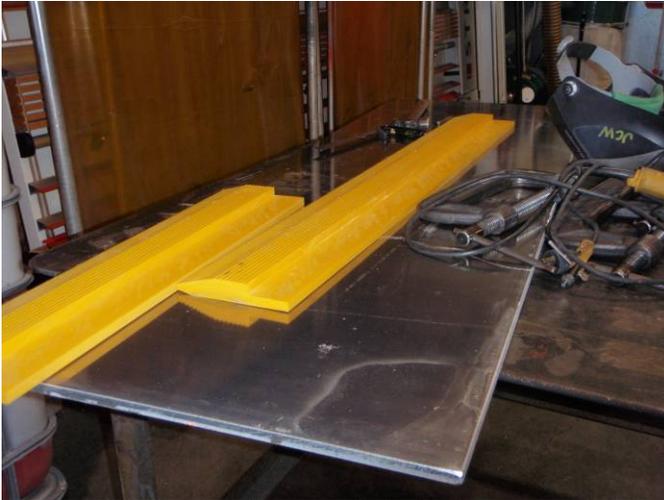
Photograph No. 8

Fabrication of the transition ramps.

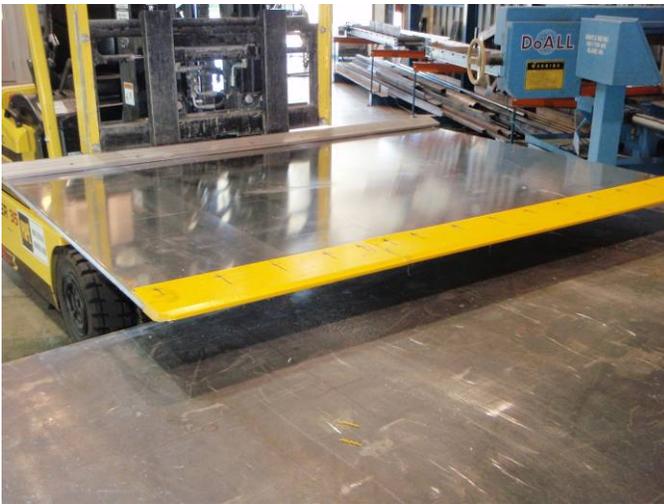
Photograph No. 9

Attaching the UHMW nosing with countersunk screws.
