Larsen Bay Health Clinic

Alaska Rural Primary Care Facility

Assessment and Inventory Report

November 14, 2001

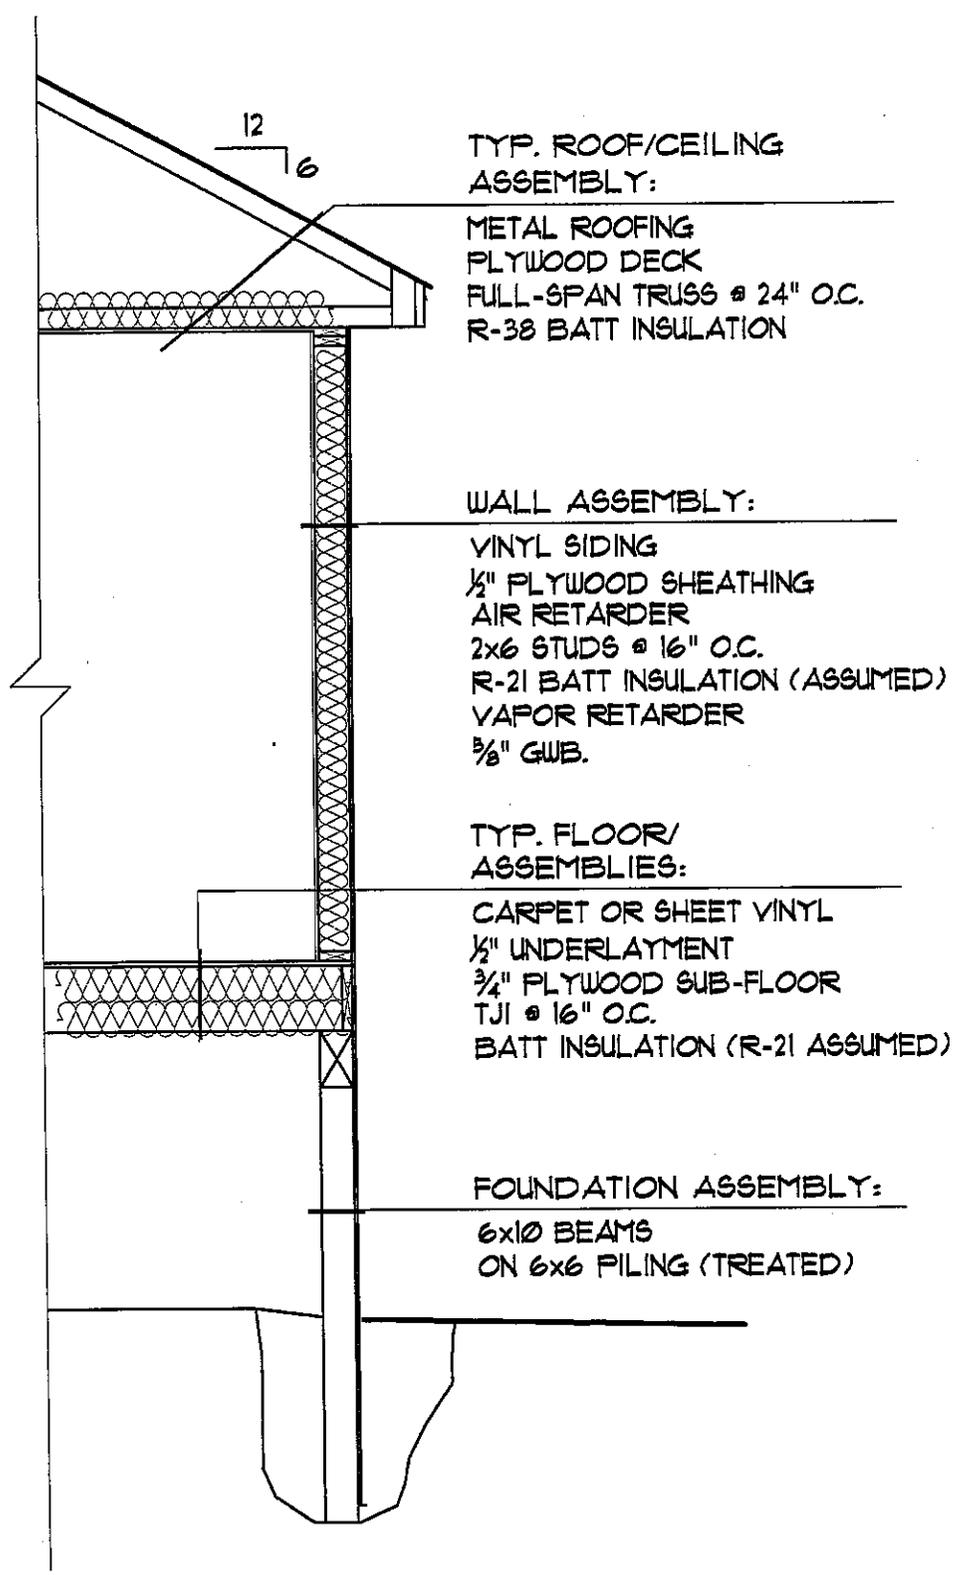
A3 Existing Wall Section

- a. Foundations: The foundations consist of a 3/4" plywood sub flooring over BSI floor joist spaced at 16" o. c. spanning over 6 x 10 wood beams supported by 6 x 6 treated piles at 8' o. c.
- a. Walls and Roof: The walls and metal roof are in good condition.
- b. Stairs, Landings and Ramps: These elements are in good condition but require code modifications, as identified in Appendix A: Specific Deficiencies.
