Manokotak Health Clinic

Alaska Rural Primary Care Facility

Assessment and Inventory Report

December 18, 2001

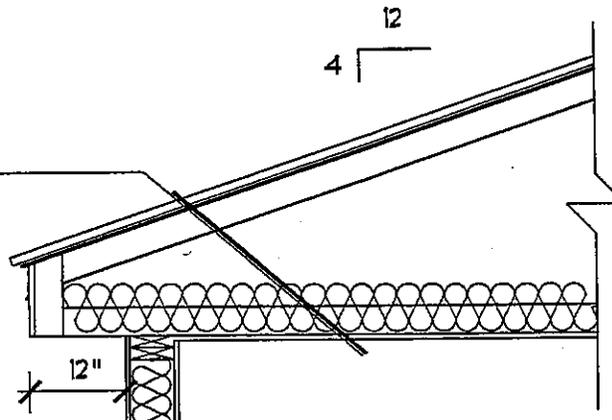
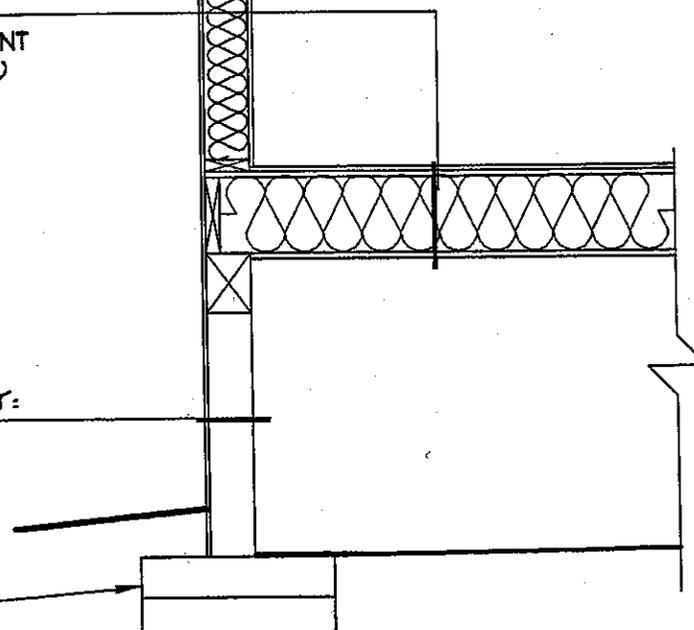
EXISTING WALL SECTION

TYP. ROOF/CEILING
ASSEMBLY:

METAL ROOF
PLYWOOD ROOF SHEATHING
WOOD TRUSS @24" O.C.
FOIL BACK INSUL.
PLYWOOD SHEATHING
ACCUSTICAL CEILING TILES

WALL ASSEMBLY:

PLYWOOD W/BATTONS @ JOINTS
2X6 @ 16" O.C. OR 24" O.C.
BATT INSUL. R-19 (ASSUMED)
WOOD PANELING

POST & BEAM
FOUNDATION ASSEMBLY:

PLYWOOD SKIRTING
2X4 STUDS

ASSUMED TREATED
FOUNDATION PAD
