KASIDAYA CREEK HYDROELECTRIC PROJECT

PROJECT NO. 11588

MONTHLY CONSTRUCTION REPORT

FEBRUARY 2007

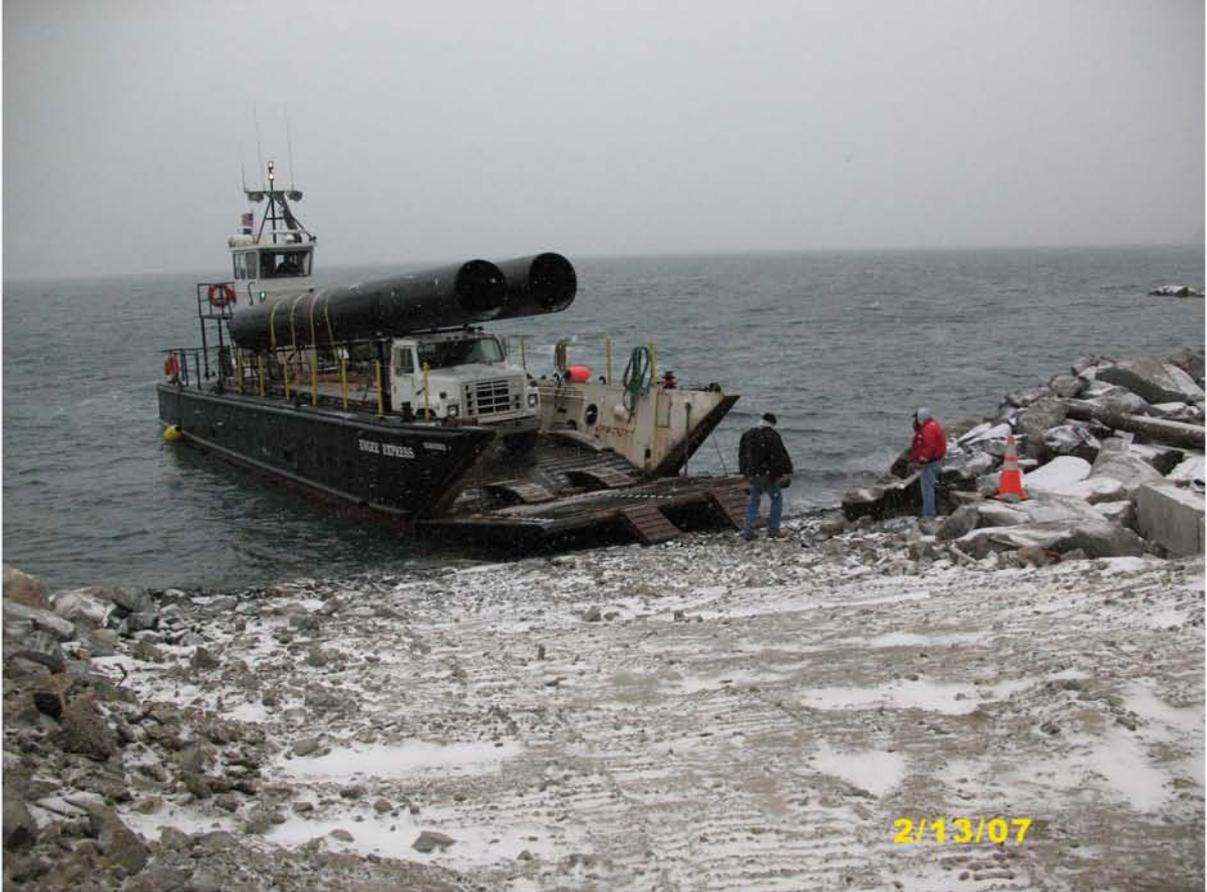
Photo 1

Unloading the truck and pipe from the Landing Craft.

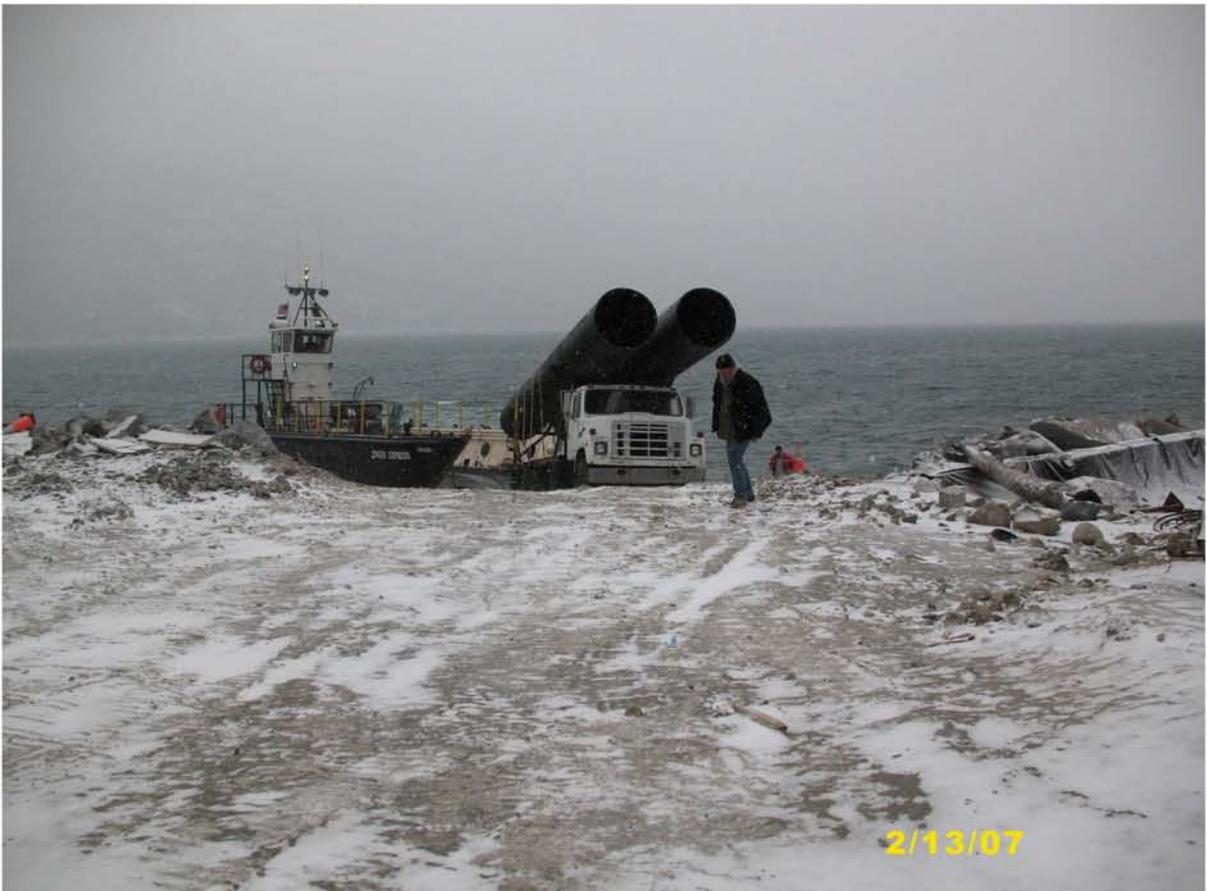
Photo 2

The truck driving off the Landing Craft.

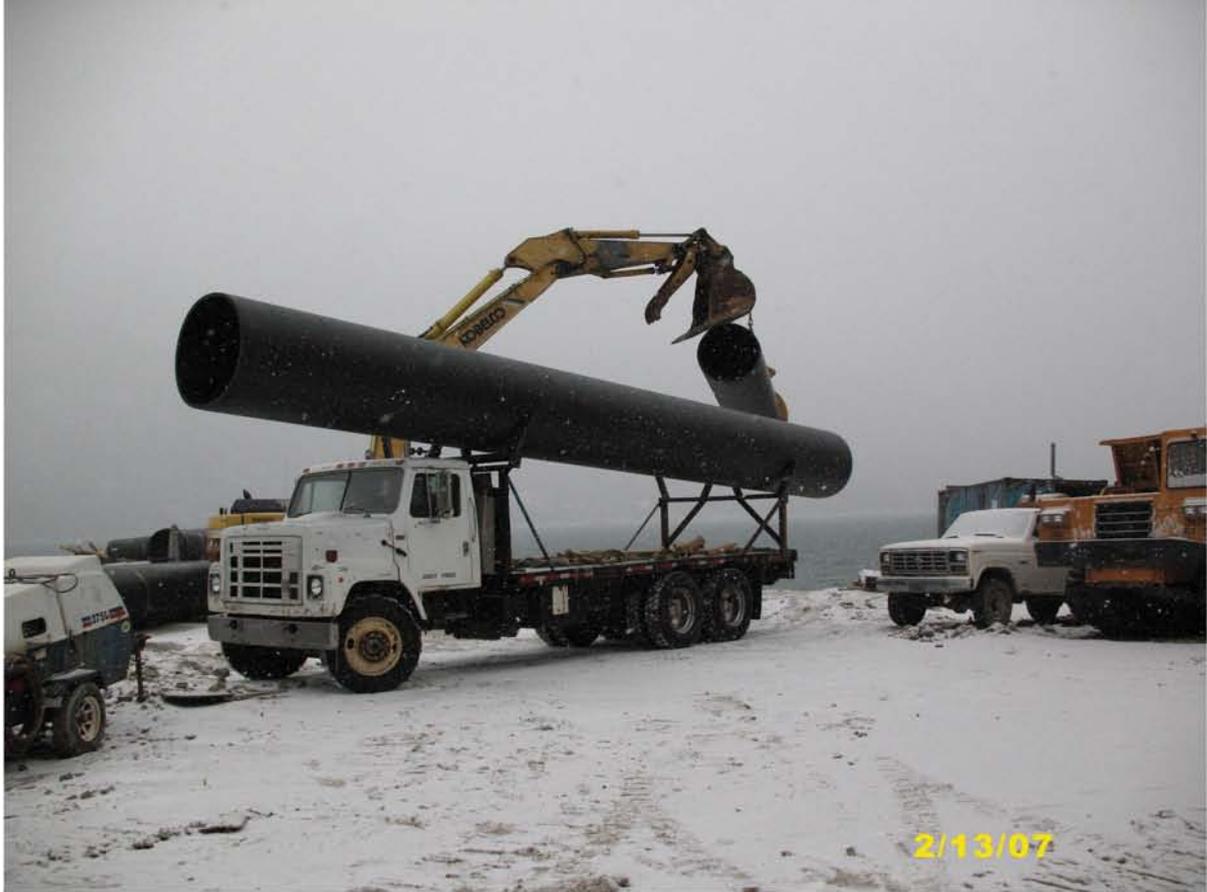
Photo 3

Unloading the pipe in the Staging Area.

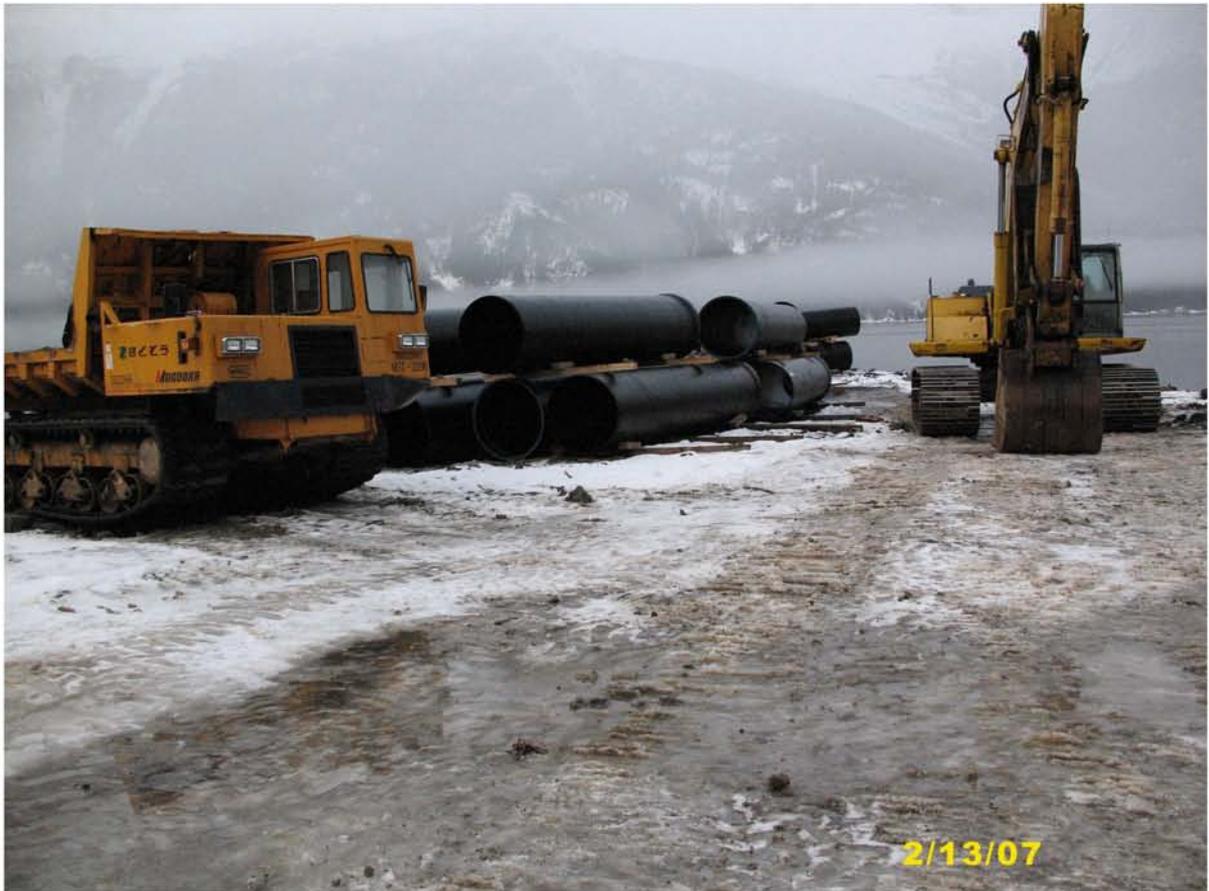
Photo 4

Stacked pipe on the south side of the jetty.

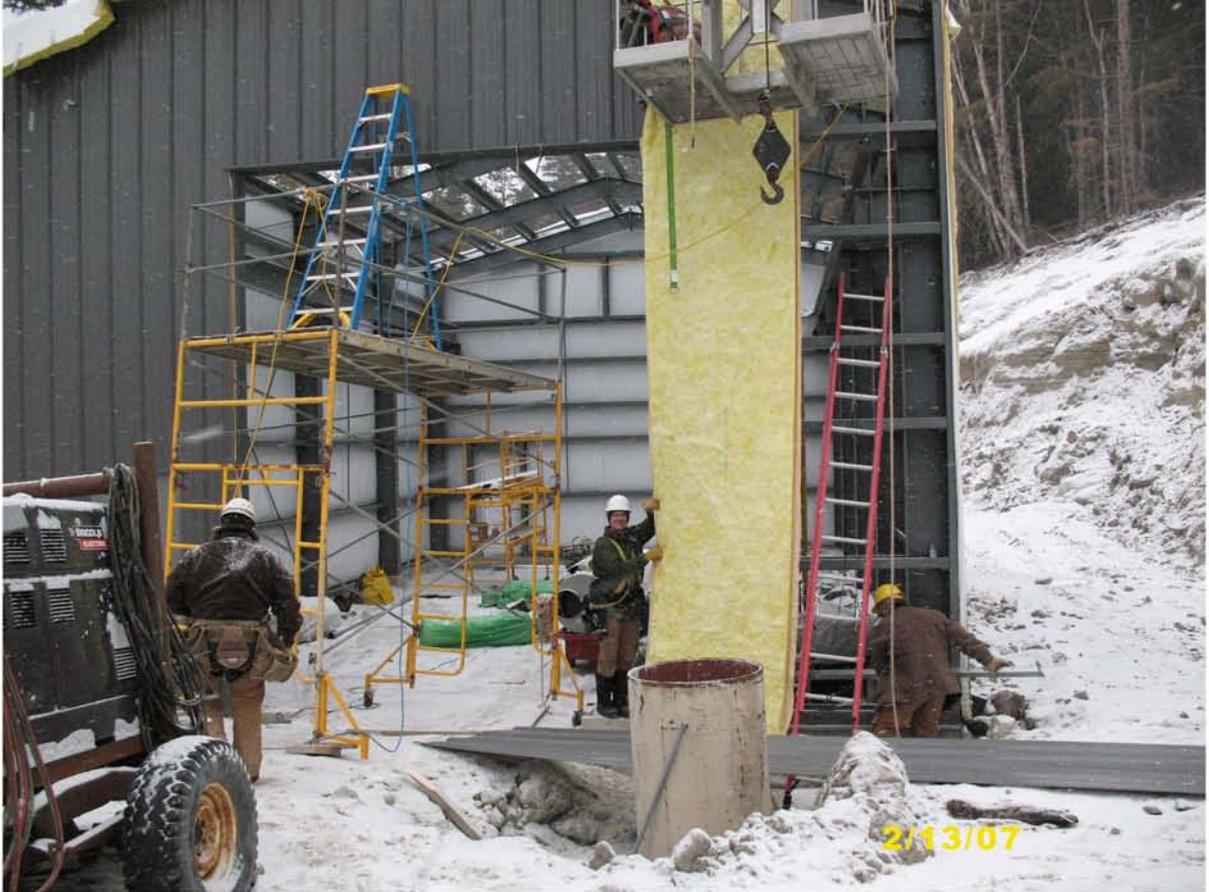
Photo 5

The Crew working on the south wall of the Powerhouse.

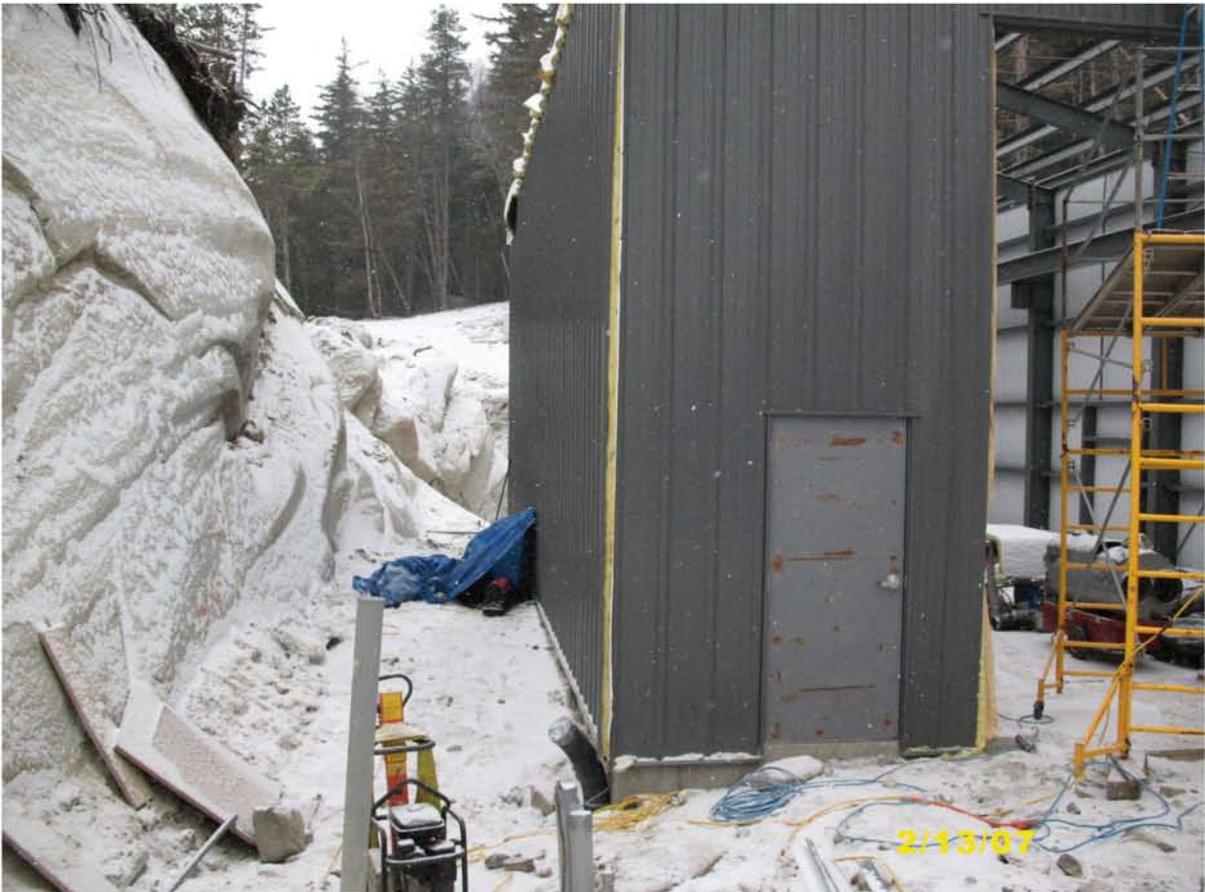
Photo 6

The southwest corner of the Powerhouse.

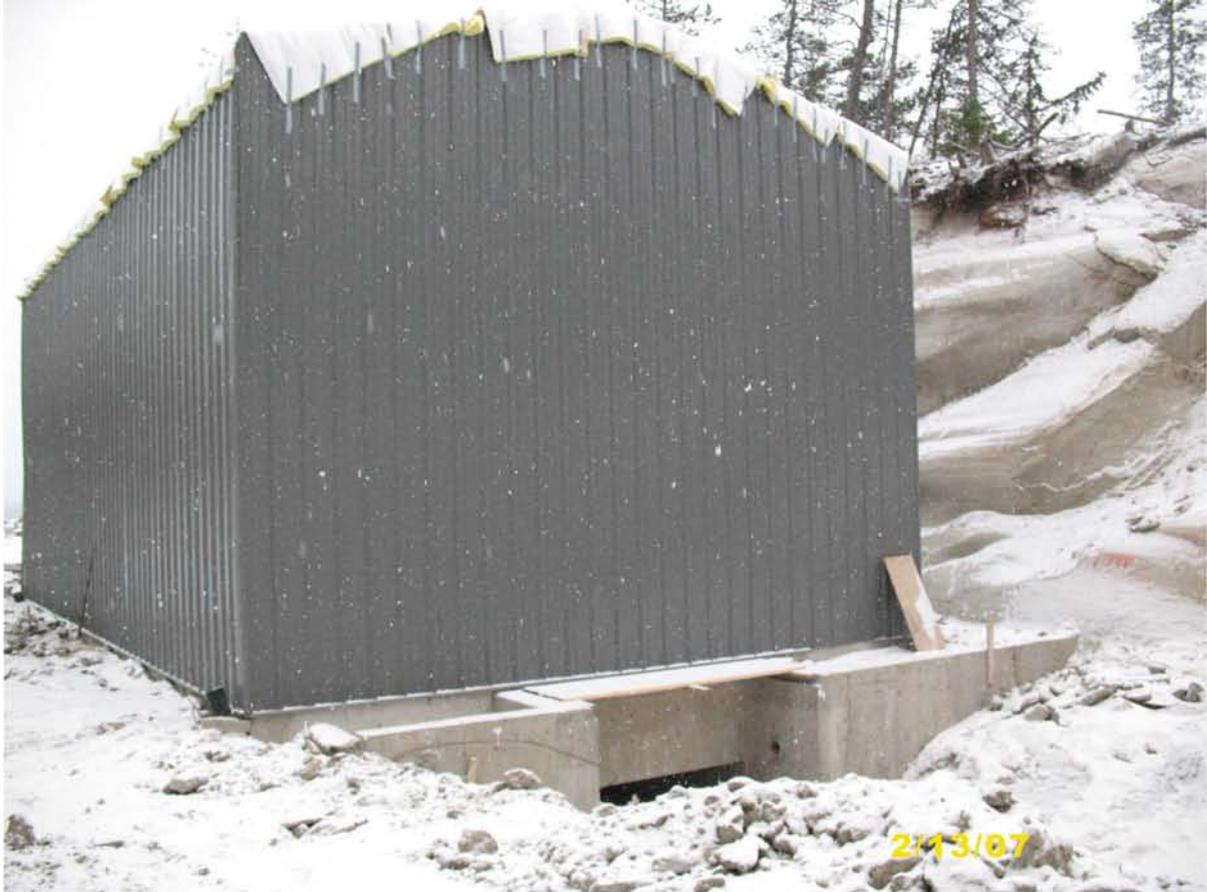
Photo 7

The north wall of the Powerhouse.

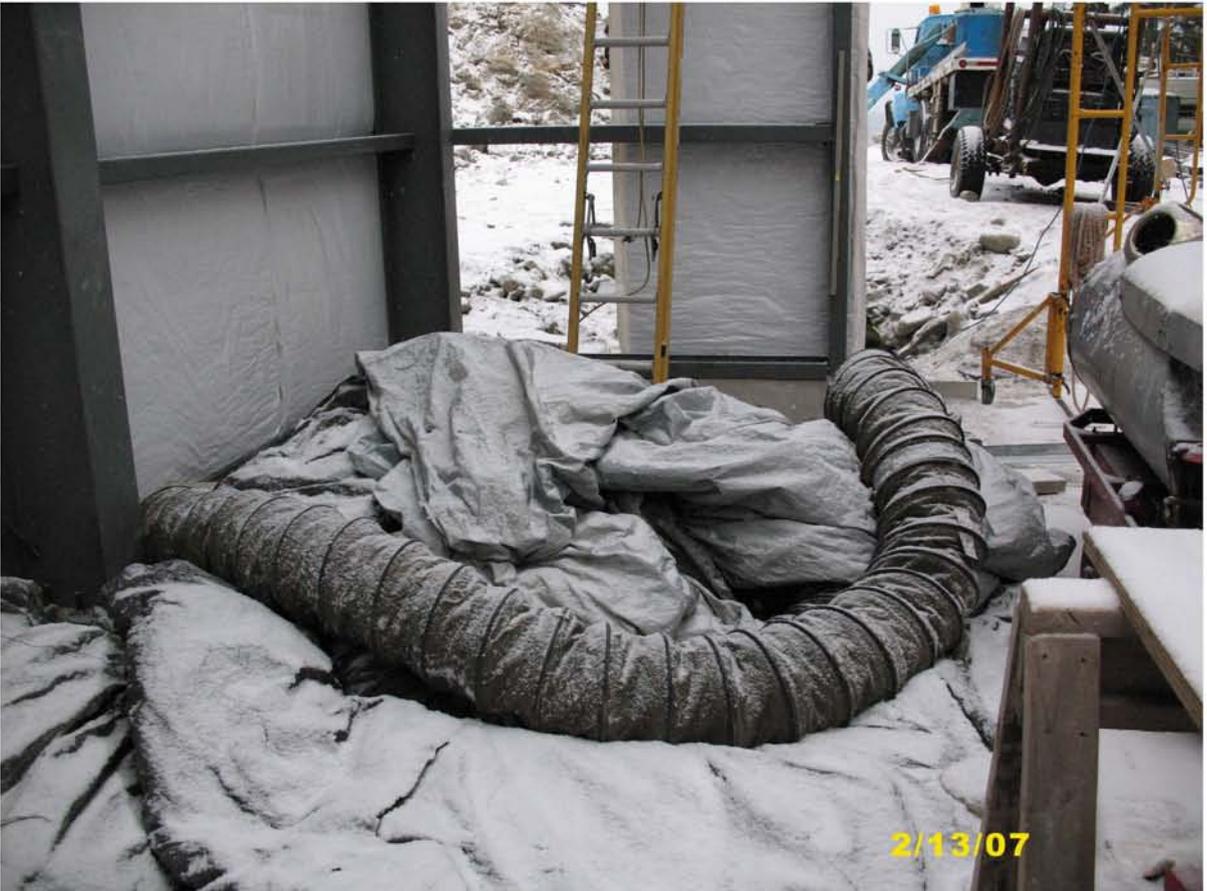
Photo 8

The southeast corner of the Powerhouse from the inside.

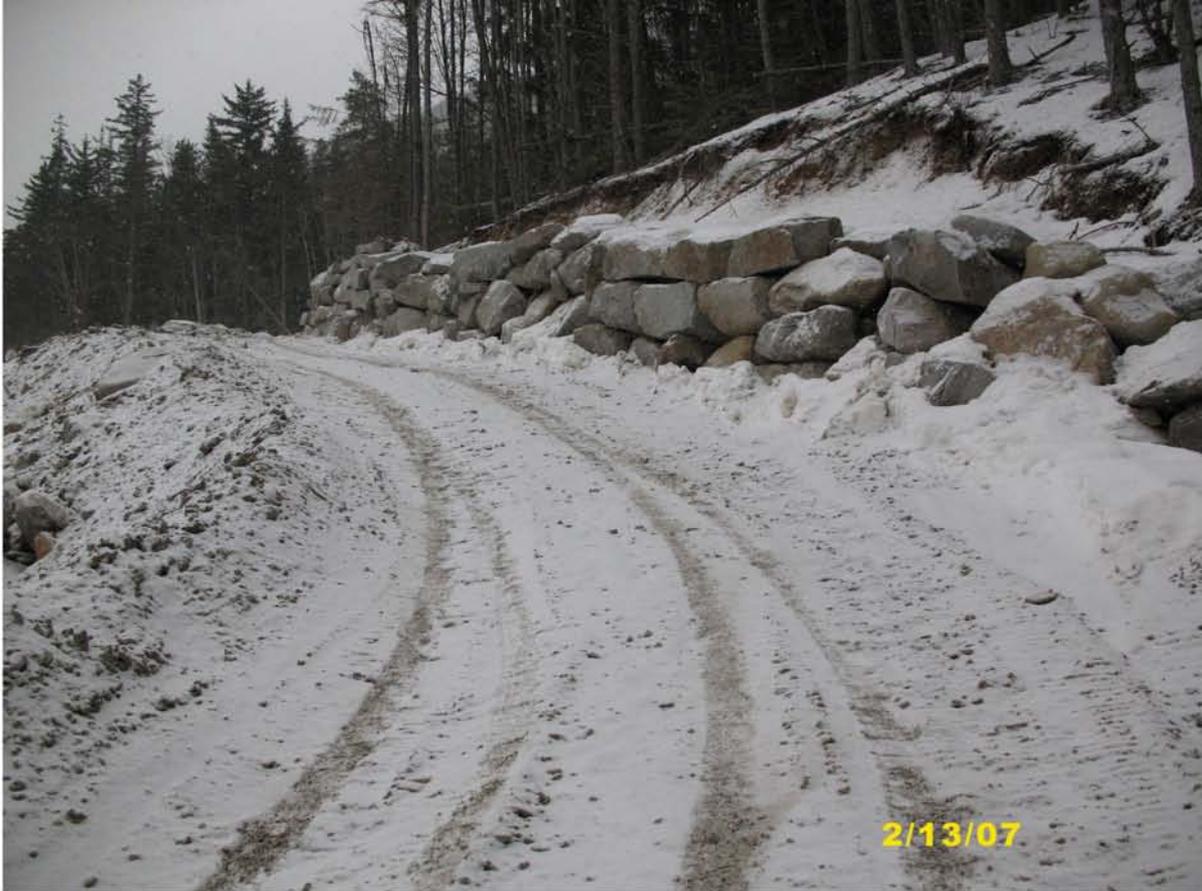
Photo 9

The beginning of the right-of-way east of the Staging Area.

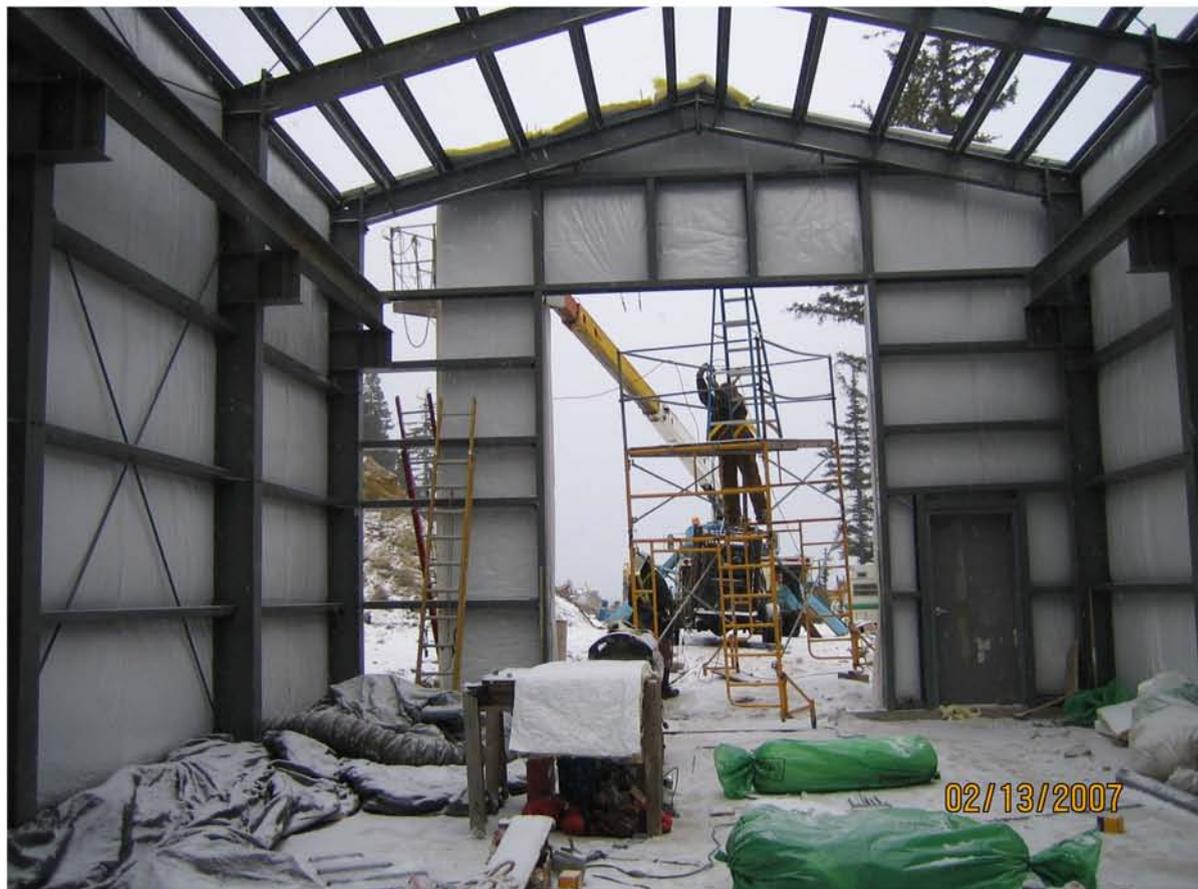
Photo 10

INSIDE POWERHOUSE

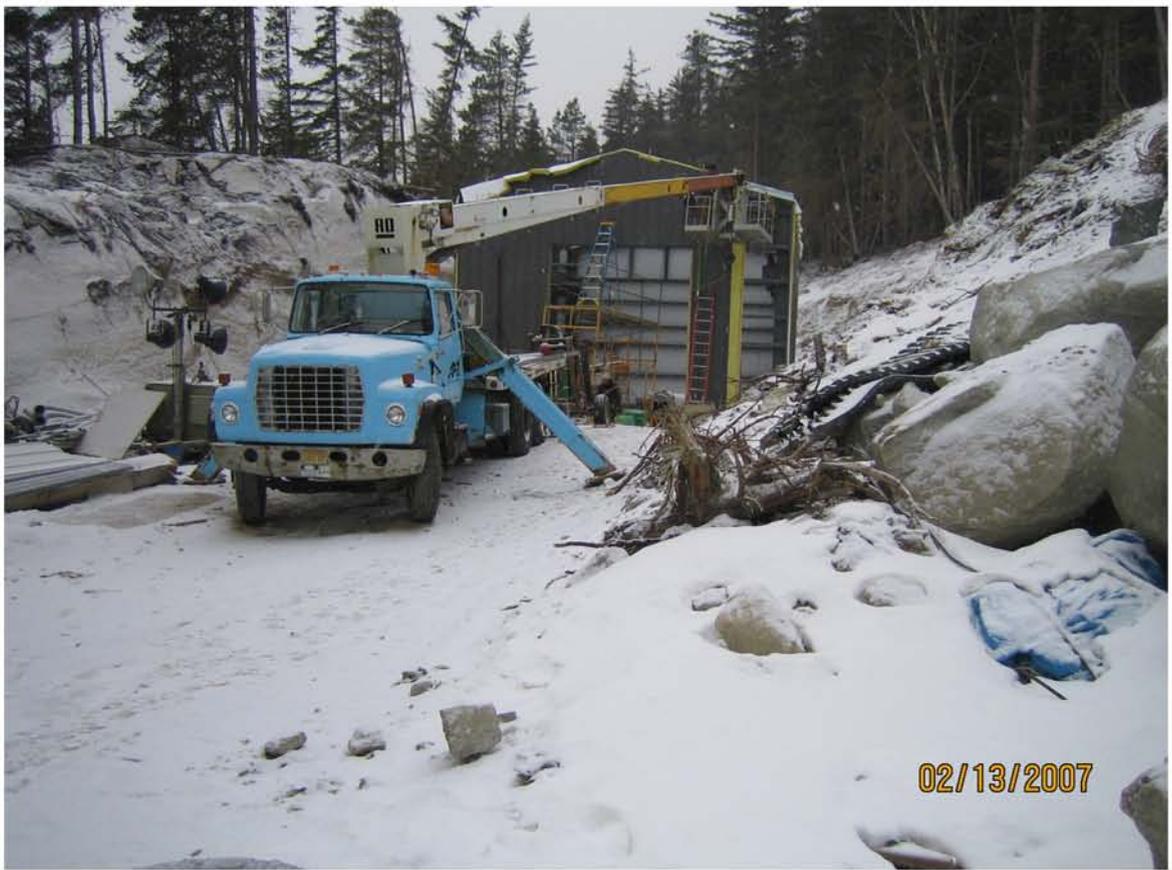
Photo 11

CONSTRUCTION OF THE POWERHOUSE
