PureCycle - Geothermal

1000 hour test qualification with > 99.9% availability

200kW Power Plant on 165 deg Water

Qualification Test Summary

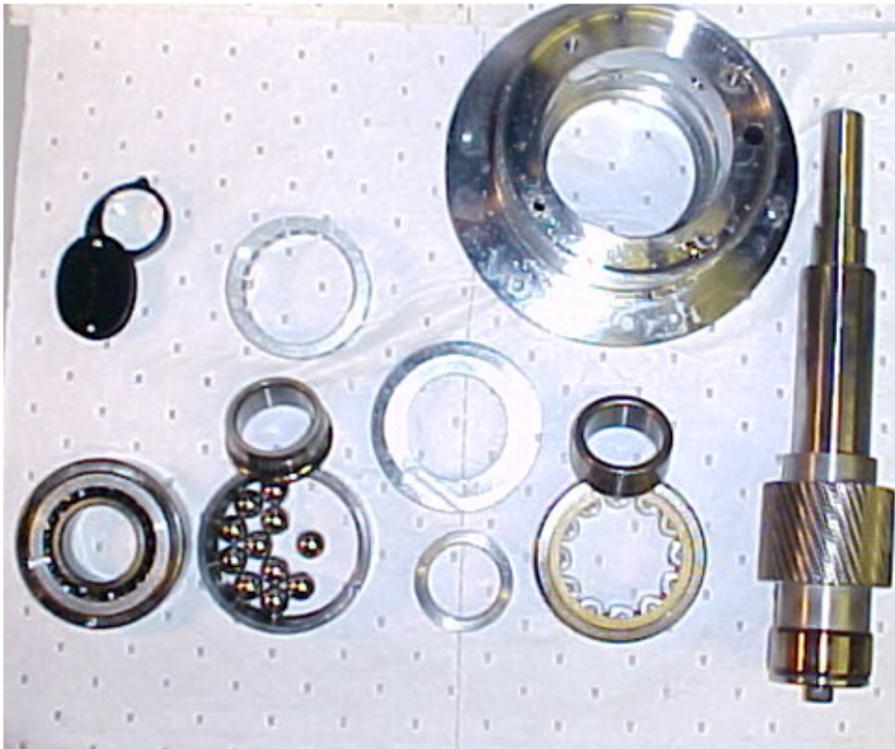
High Speed Shaft Disassembled

Both high speed and low speed bearings are in excellent condition

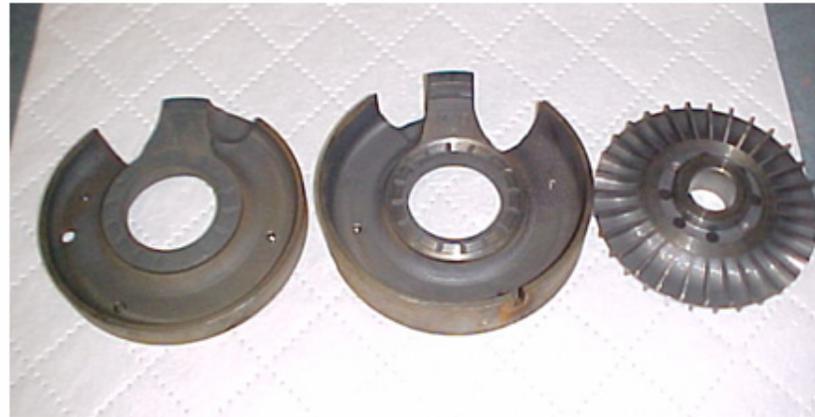
Filtering upstream of pump reduced/eliminated FOD damage

No cavitation damage on impeller after 1000 hours

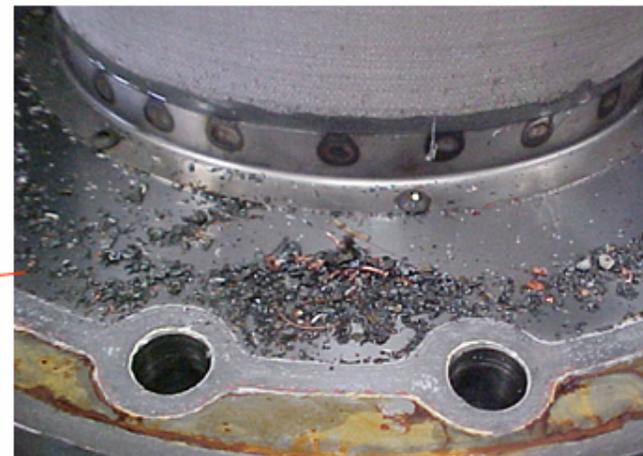
Debris – condenser exit

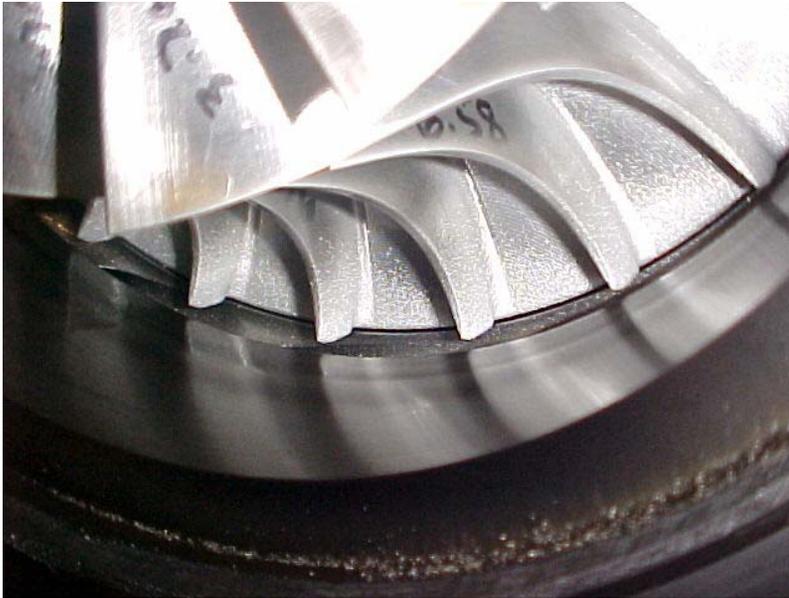
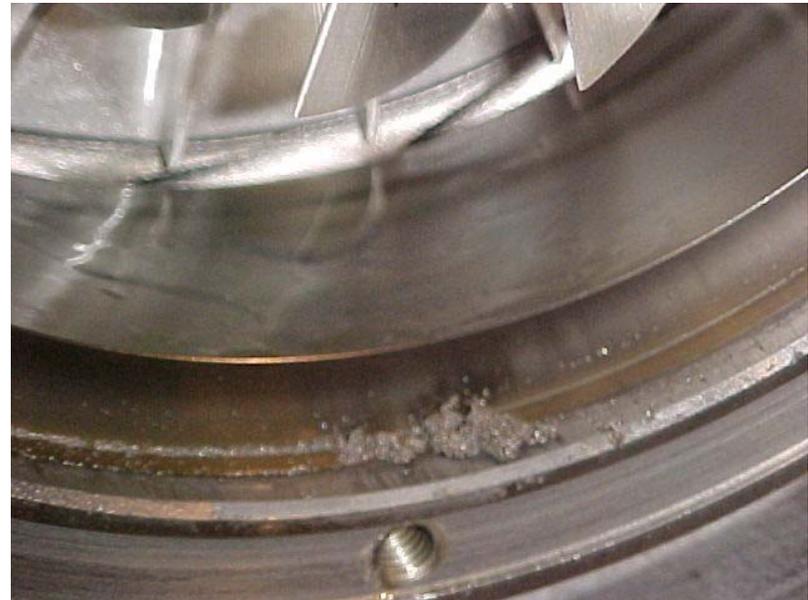
Impeller Erosion – Due to failed filter at nozzle Inlet

Issue is under investigation
