Gustavus Electric Company

March 2007 Monthly Report for the Falls Creek Hydro-electric Project
FERC # P-11659

Falls Creek Hydroelectric Project (P-11659)
MONTHLY CONSTRUCTION REPORT TO FERC
March 2007

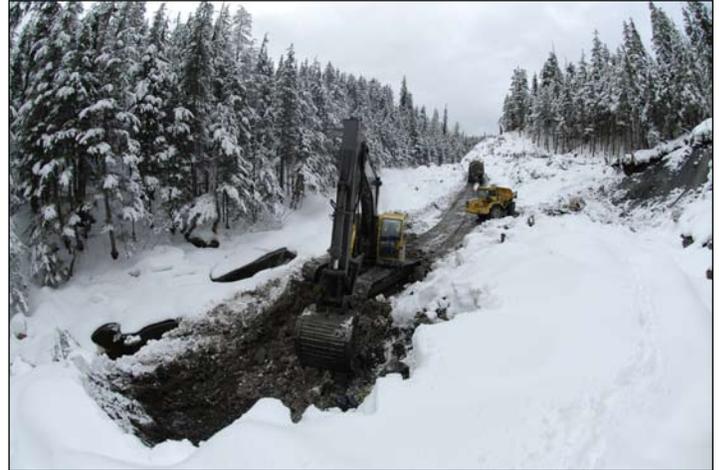
Excavation at the Intake site.

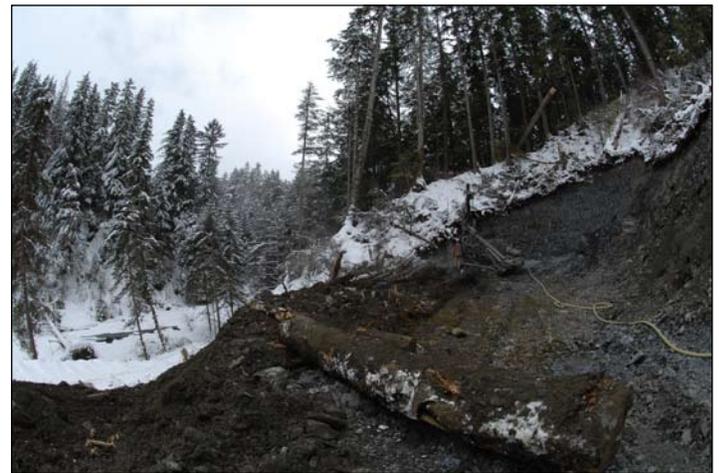
Early phase of drilling for the powerhouse grade.

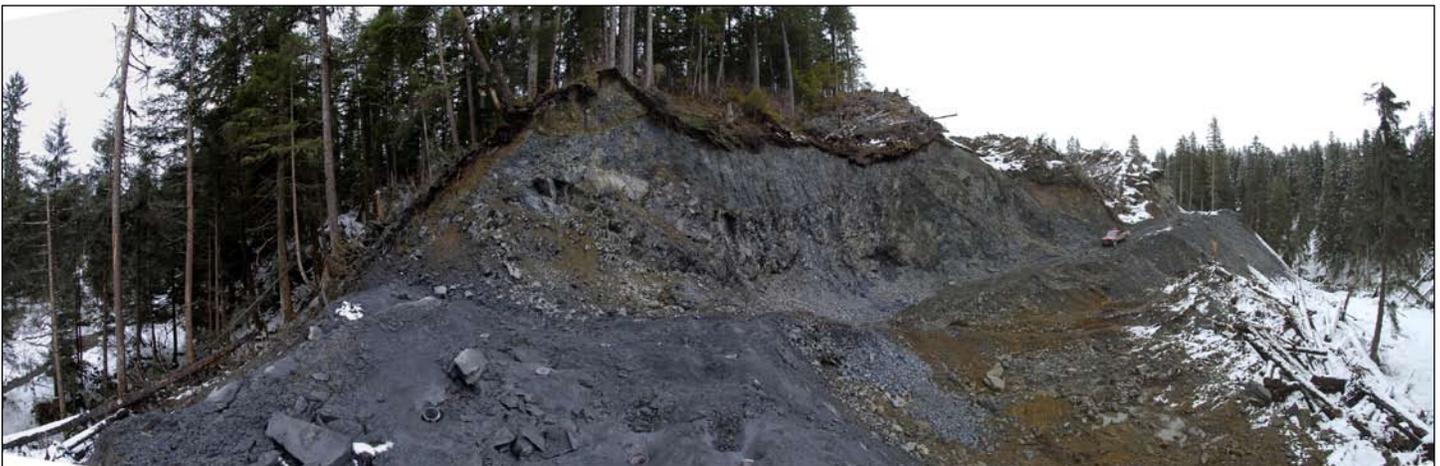
This was the scene at the powerhouse site on March 30. Very wide angle photo (~270 degrees view).

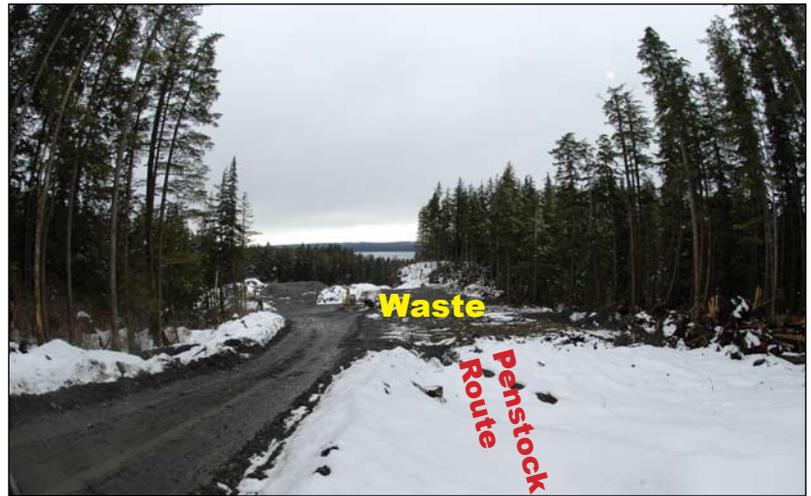
Waste from the powerhouse excavation was dumped in the steel penstock right of way clearing.

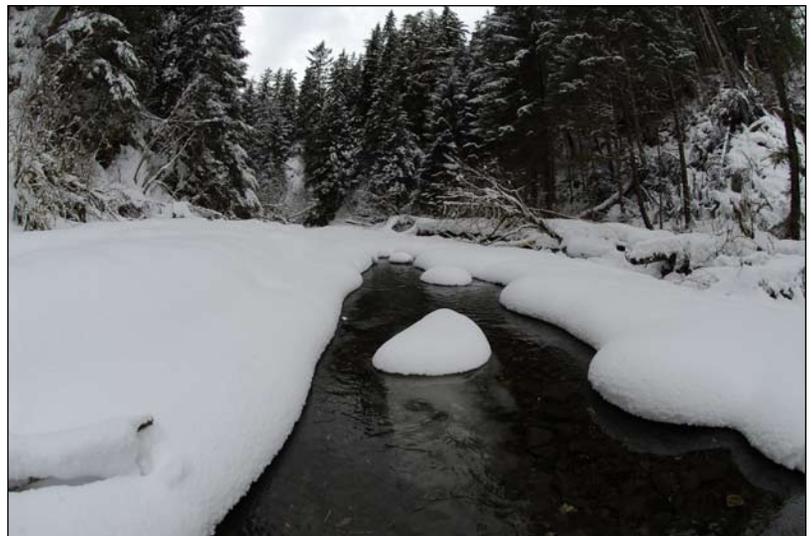
A few openings in the surface ice developed in the anadromous reach during the second half of March.

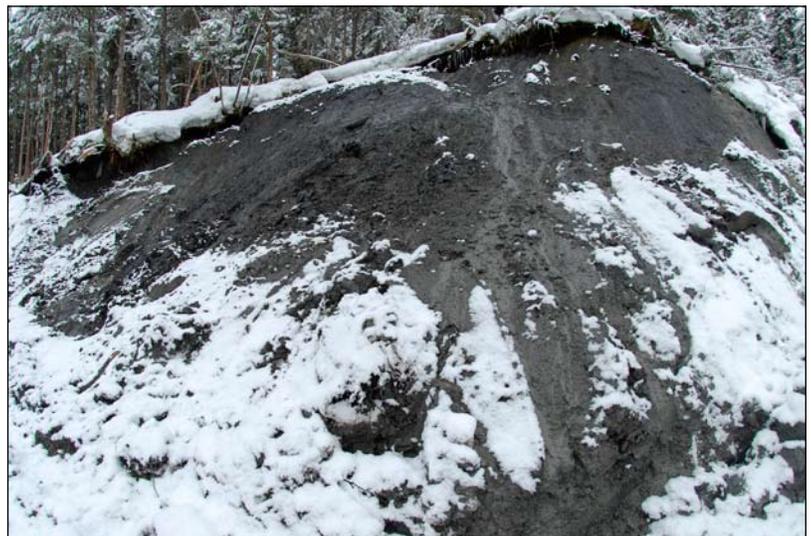
Till cut-banks continued to slough material even during the colder weather. When temperatures warmed in the latter part of March the banks began to weep and ooze down into the ditches and onto the road. Very little sediment was added to the stream by these sources because the construction crew performed maintenance when necessary and because the shot-rock road is doing an excellent job of capturing most of the material. A long-term plan for how to manage erosion and sediment at the exposed till slopes will be drafted this spring.

Till cut-banks along the road, above the intake and above the powerhouse slough blocks of till and ooze fine sediments when they get wet.

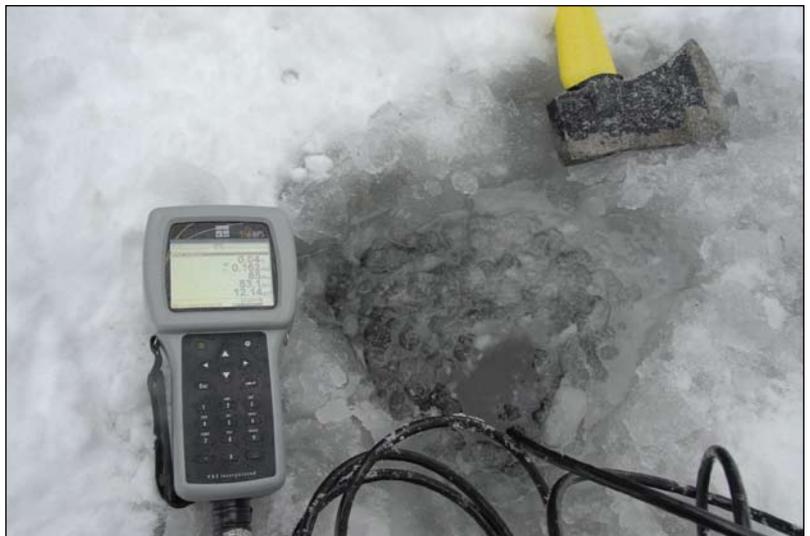
A YSI probe was used this month to measure dissolved oxygen in frozen over pools. Results were ~ 12 mg/L

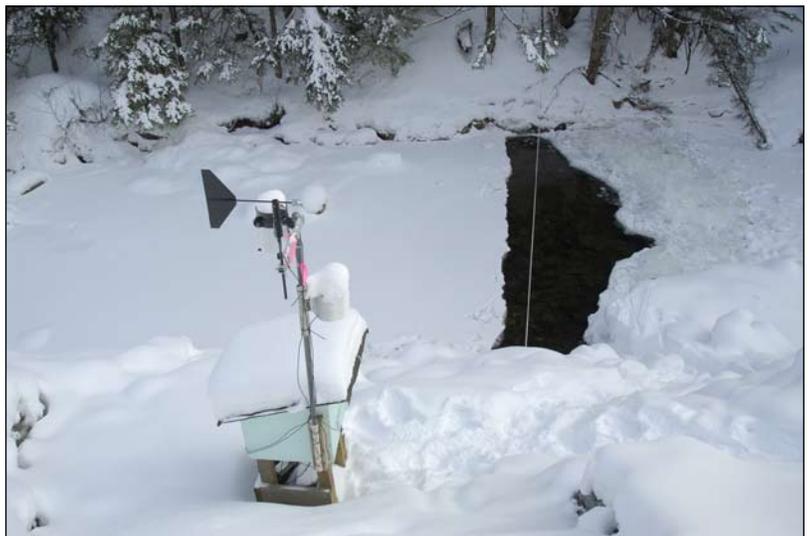
Weather station for ice model in the foreground. An area of the creek near the intake was kept free of ice to allow for manual discharge measurements during low flows.

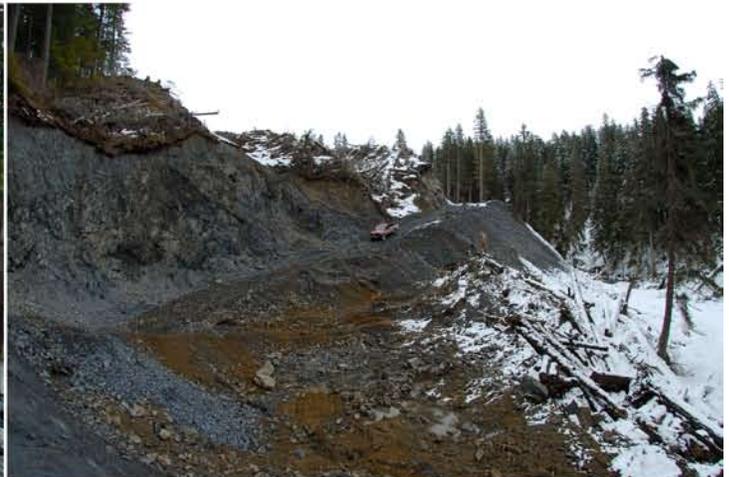
10_photo_site.jpg

Ten photo vantage points have been established throughout the project area. Very little change occurred at photo points with the exception of the powerhouse (point 10).

Photo site 10 has been moved to the location of the powerhouse.
