Little Diomed Health Clinic

Alaska Rural Primary Care Facility

Assessment and Inventory Report

April 11, 2002

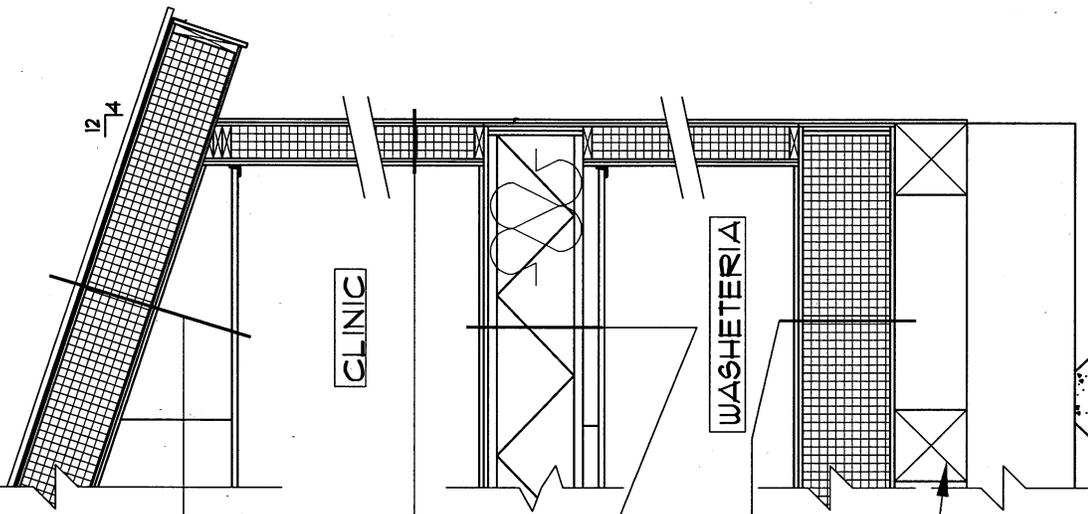
EXISTING WALL SECTION

ASSEMBLIES
 FLOOR:
 SHEET VINYL
 UNDERLAYMENT
 FLYWOOD SUBFLOOR
 BAR JOIST
 BATT INSULATION (AT RIM)
 SUSPENDED CEILING
 GROUND FLOOR ASSEM.
 SHEET VINYL
 UNDERLAYMENT
 INSULATED FLOOR PANEL

12X12 BEAMS OVER
 5-1/8" X 18" GLULAM BEAM ON
 18" DIA. CONCRETE
