PureCycle - Geothermal

1000 hour test qualification with > 99.9% availability

200kW Power Plant on 165 deg Water

Qualification Test Summary

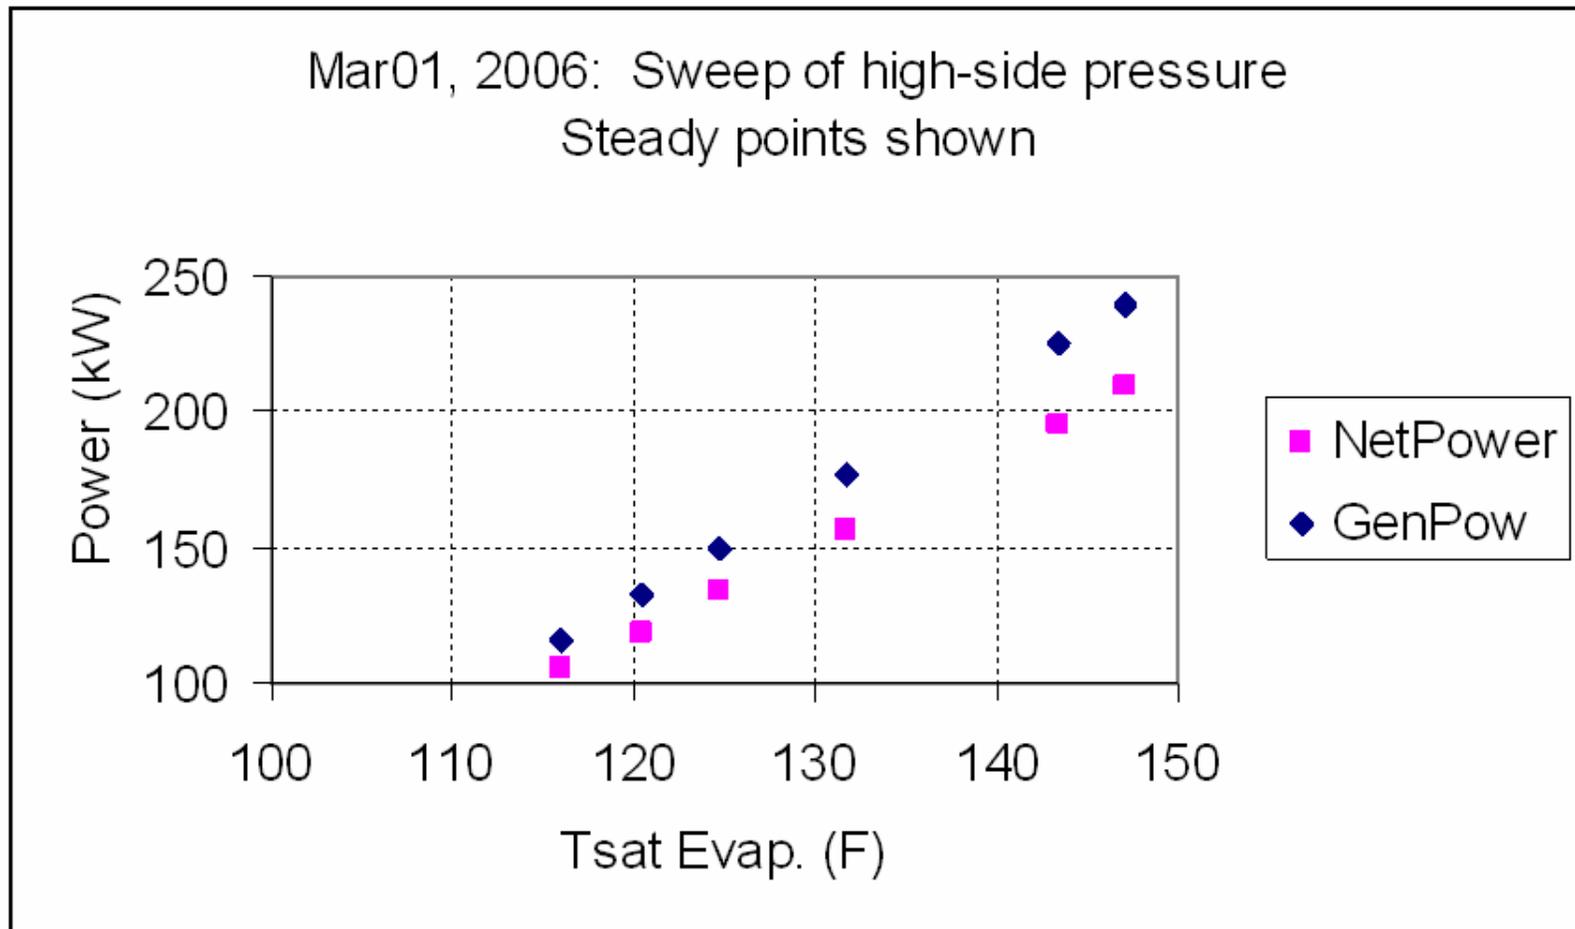
Power Variation with Change in High-side Pressure ✓

Hot water flow rate and temperature was varied to study system response at off-design.

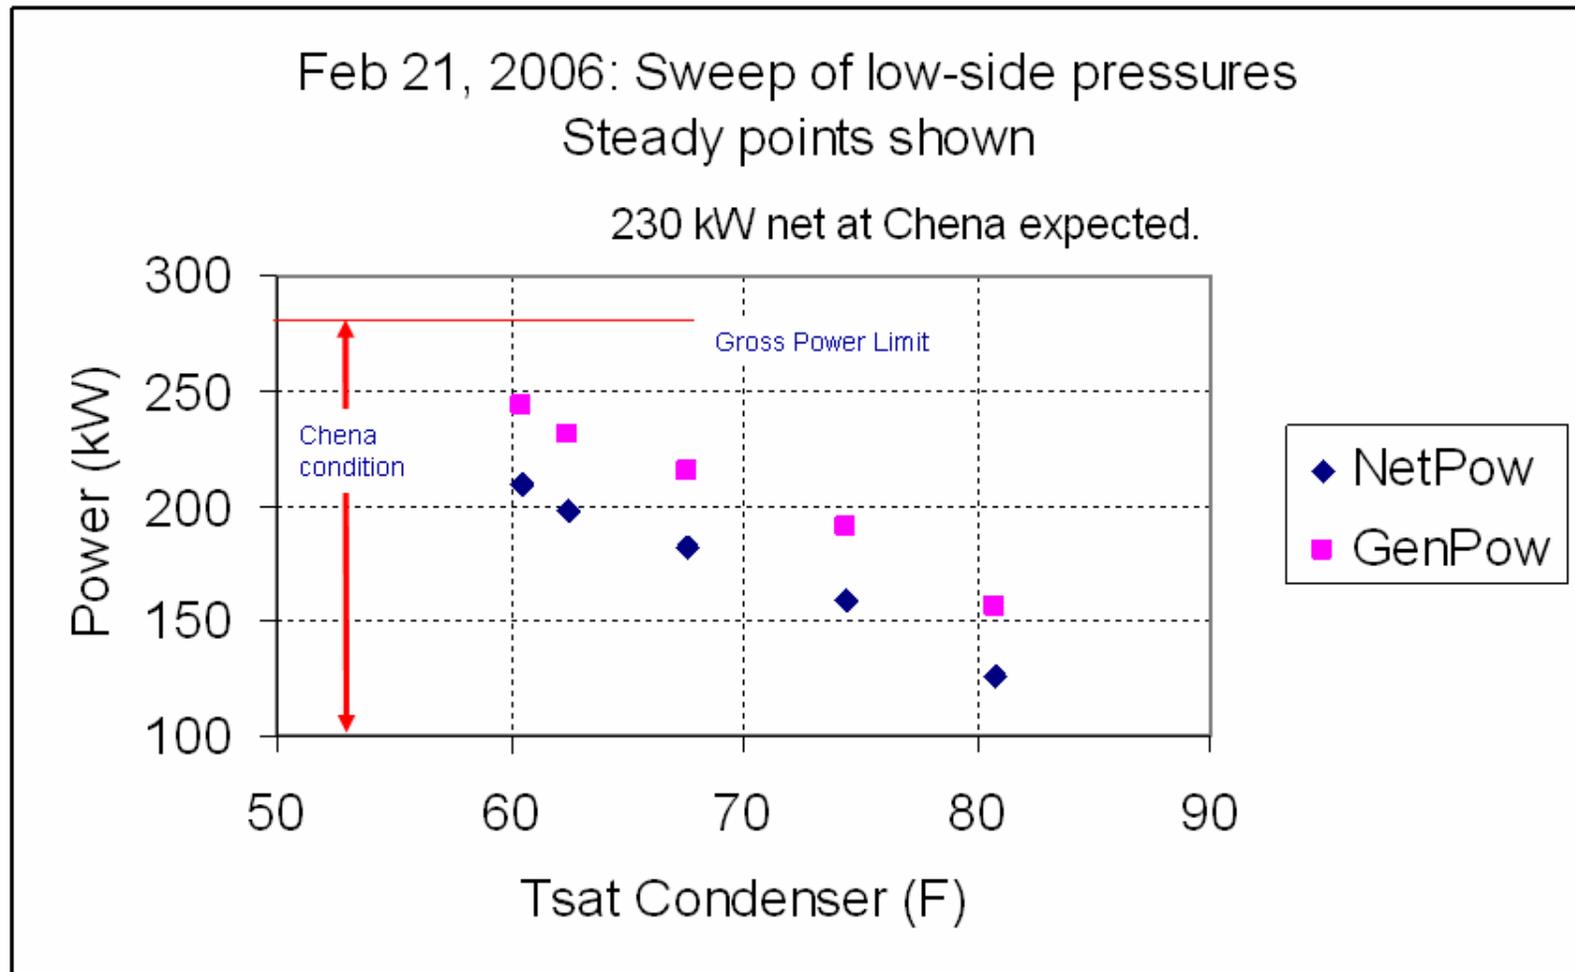
Power Variation with Change in Low-side Pressure ✓

Cold water flow rate was varied to study system response at off-design.

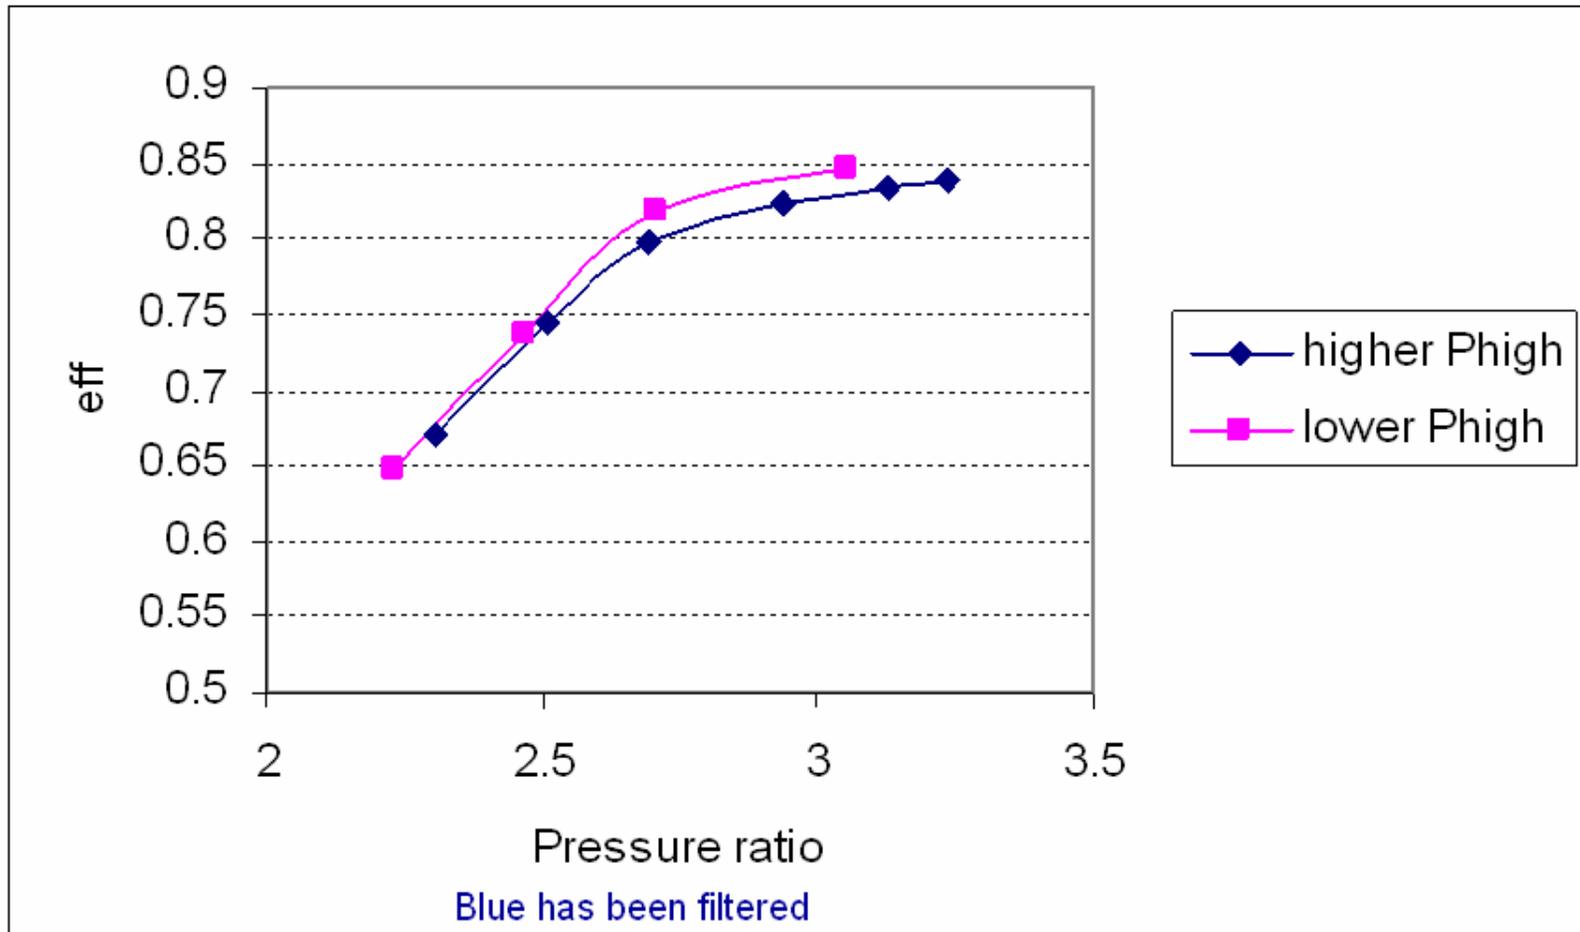
Turbine/generator Performance ✓

Turbine isentropic efficiency calculated from data

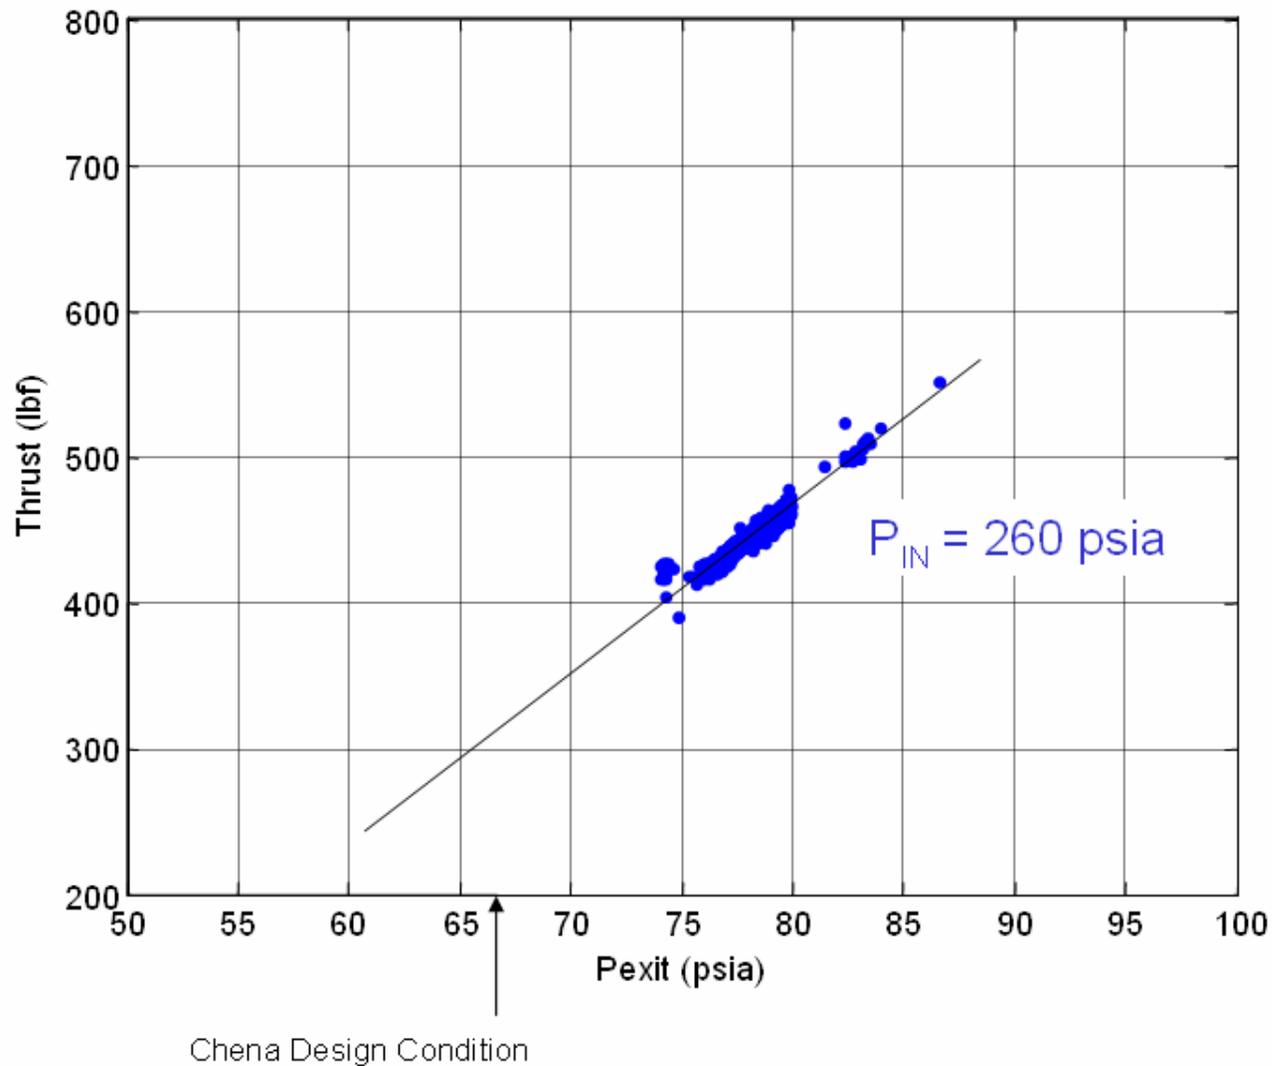
Turbine Axial Thrust ✓

Thrust calculated from pressure data is well below 1200 lb limit
