## CONCEPTUAL DESIGN REPORT

## ATMAUTLUAK ELECTRICAL DISTRIBUTION SYSTEM UPGRADE

February 14, 2002

*Prepared by:*  
Wiley W. Wilhelm, P.E

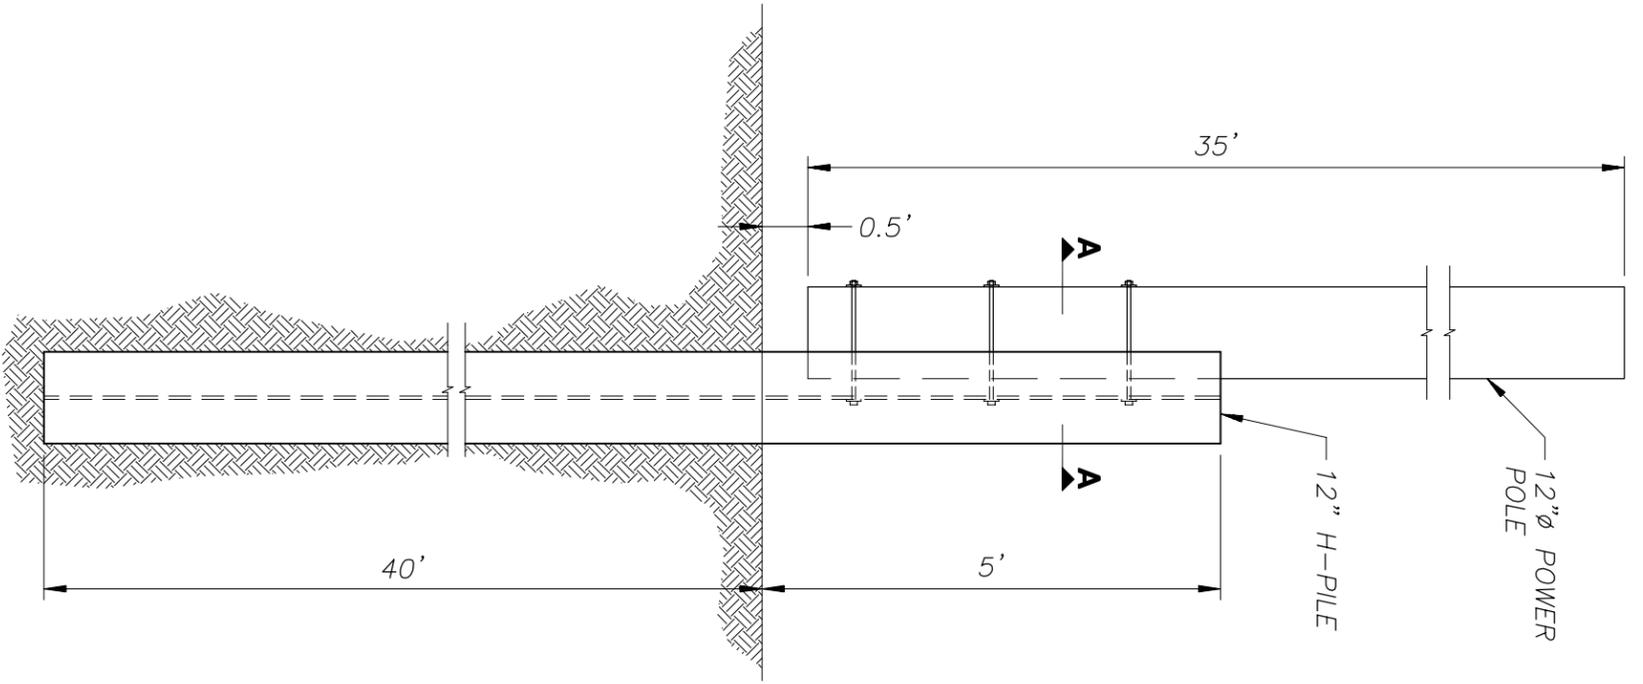
# TYPICAL PILE SECTION

SCALE: 1" = 2'

(3) 1 1/2"  $\phi$  GALV.  
 BOLT WITH WASHERS  
 AND NUTS

## A - A
