LIME VILLAGE HEALTH CLINIC

Alaska Rural Primary Care Facility Code and Condition Survey

January 8, 2002

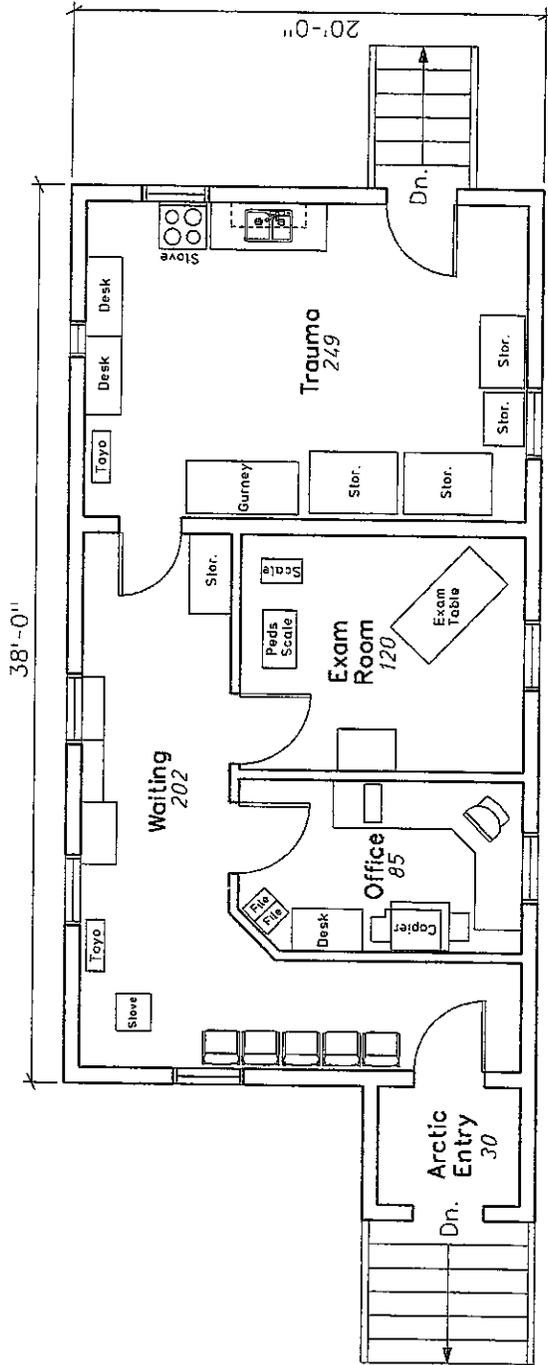
Existing Lime Village Clinic Floor Plan

Scale: 1/8" = 1'-0" 801 Sf.

- a. Overall space deficiencies: The size of the facility is about 699 sf short of the ARPCF space requirements.
- b. Specific room deficiencies: There is minimal vestibule, small waiting space, minimal office and storage space, no TDY, and combined trauma. This in combination with other small spaces leaves the clinic very program deficient.
- c. Other size issues: Mechanical room is non-existent, and there are no unheated or exterior storage areas, and circulation is through rooms such as trauma to get to second exit.

- A1.1 Existing Site Plan is attached if available
- A1.2 Existing Facility Floor Plan is attached following.
- A1.3 The Existing typical wall section is attached following as required by the report guidelines.
- A2.1 The Addition to the Existing Facility as required to meet ARPCF Space Guidelines is attached following.
- A3.1 The New Clinic Site plan is attached as proposed based on the community input.
- A3.2 The New Denali Commission Clinic Floor Plan meeting the ARPCF Space Guidelines and proposed for this location is attached.

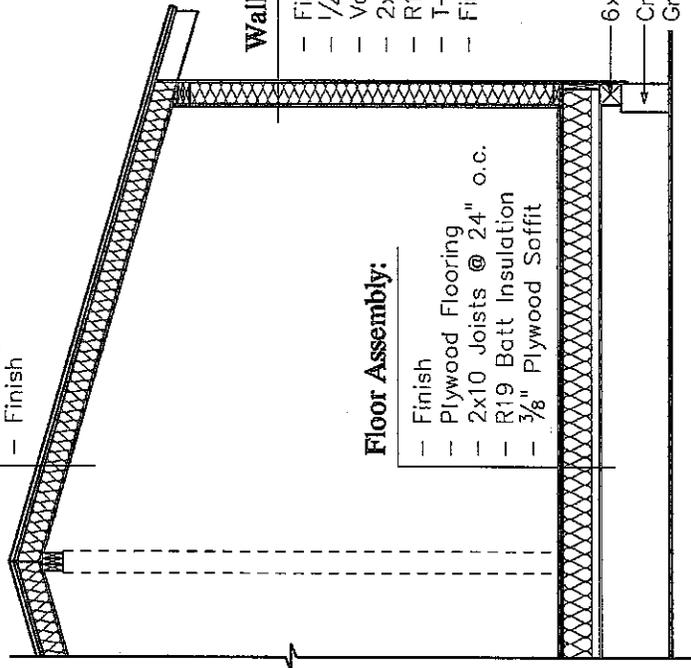
Roof Assembly:

- Prefinished Metal Roofing
- Plywood Deck
- 2x6 Joist @ 24" o.c. w/ Corner Beam Supports
- R24 Batt Insulation
- 1/4" Plywood
- Finish

Wall Assembly:

- Finish
- 1/4" Plywood Paneling
- Vapor Barrier
- 2x6 @ 24" o.c.
- R19 Batt Insulation
- T-111 Plywood
- Finish

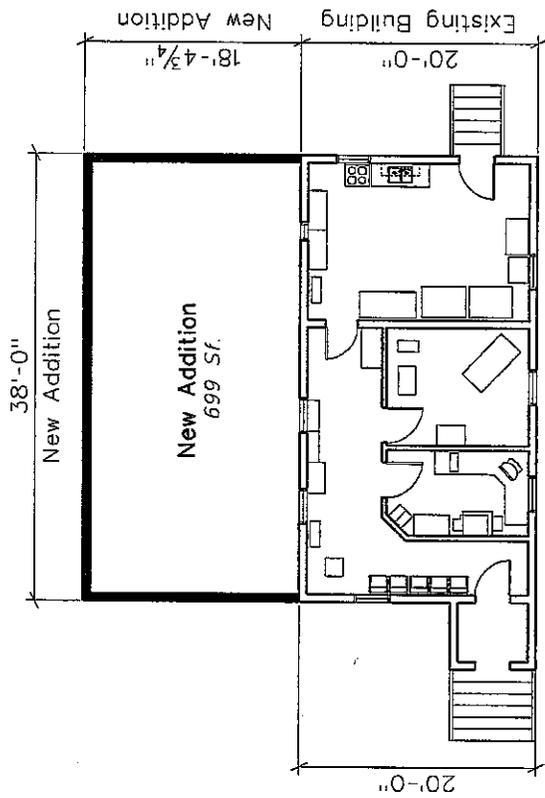
New Addition Lime Village Clinic Floor Plan

699 Sf. + 801 Sf. = 1,500 Sf.
